**Terry's of York
Head Office and Multi-Storey Factory Building
Bishopthorpe Road
York**

Level 2 Building Survey

**Terry's of York
Head Office and Factory Building
Bishopthorpe Road
York**

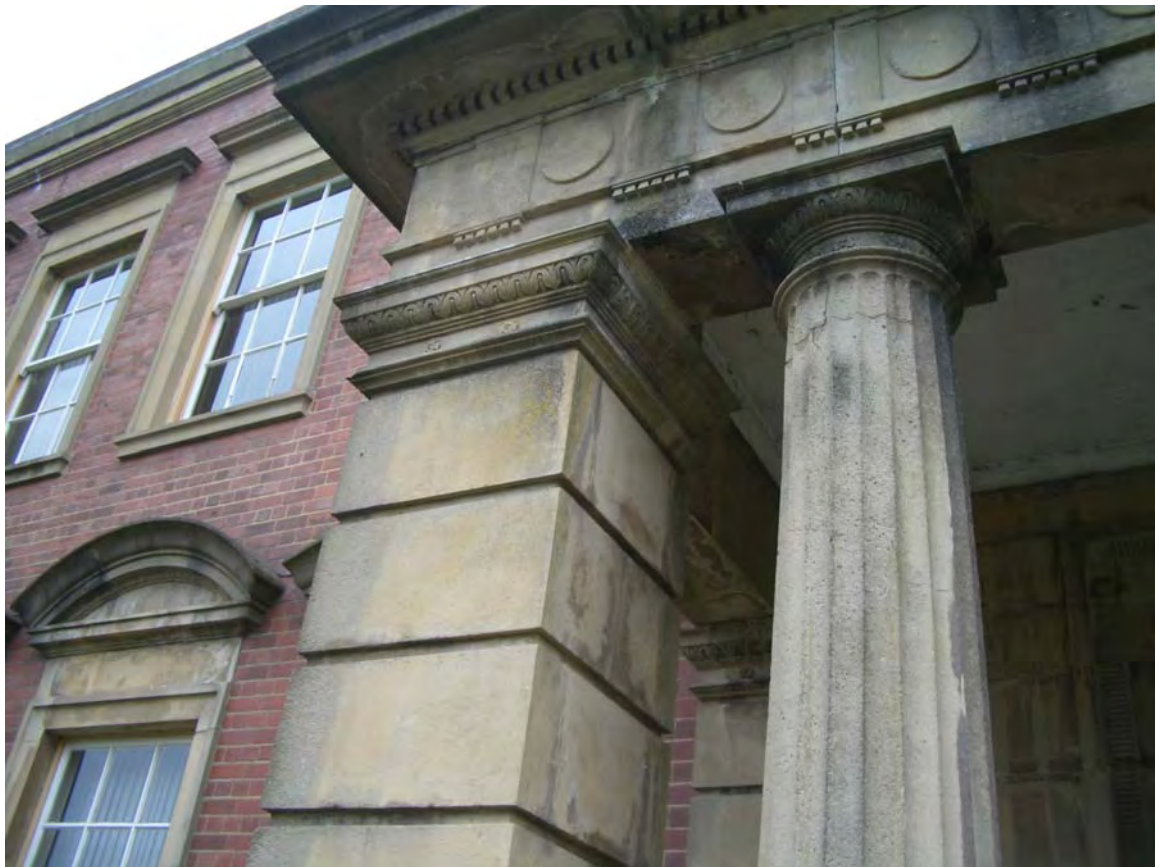
Plate 16. Head Office. East Elevation Detail of Porch Moulding. Facing West.

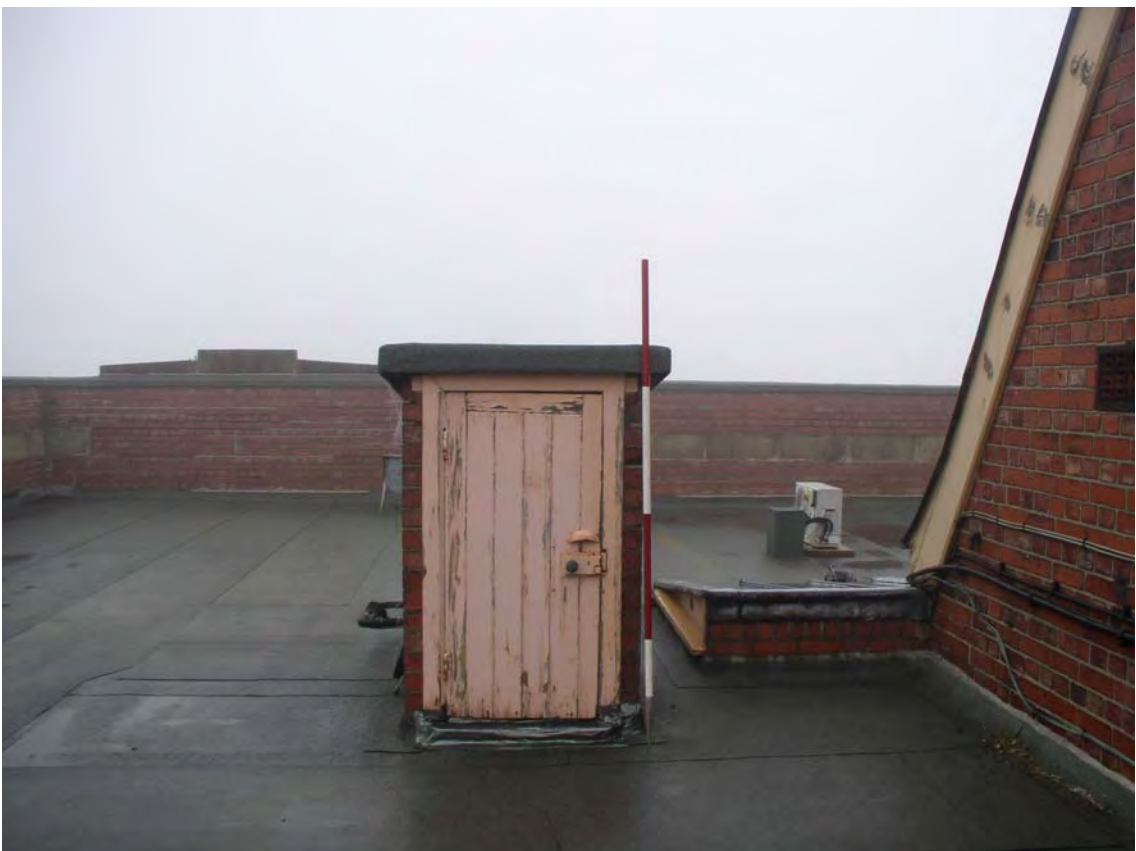
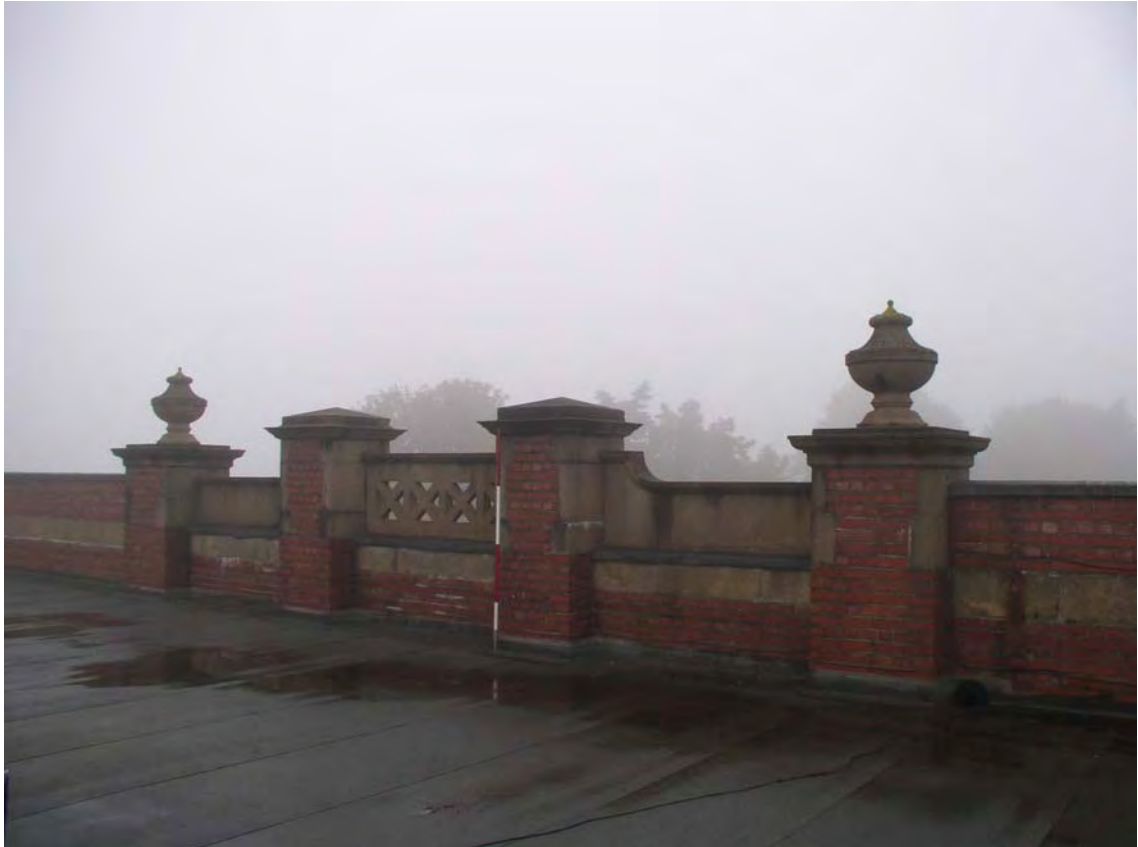
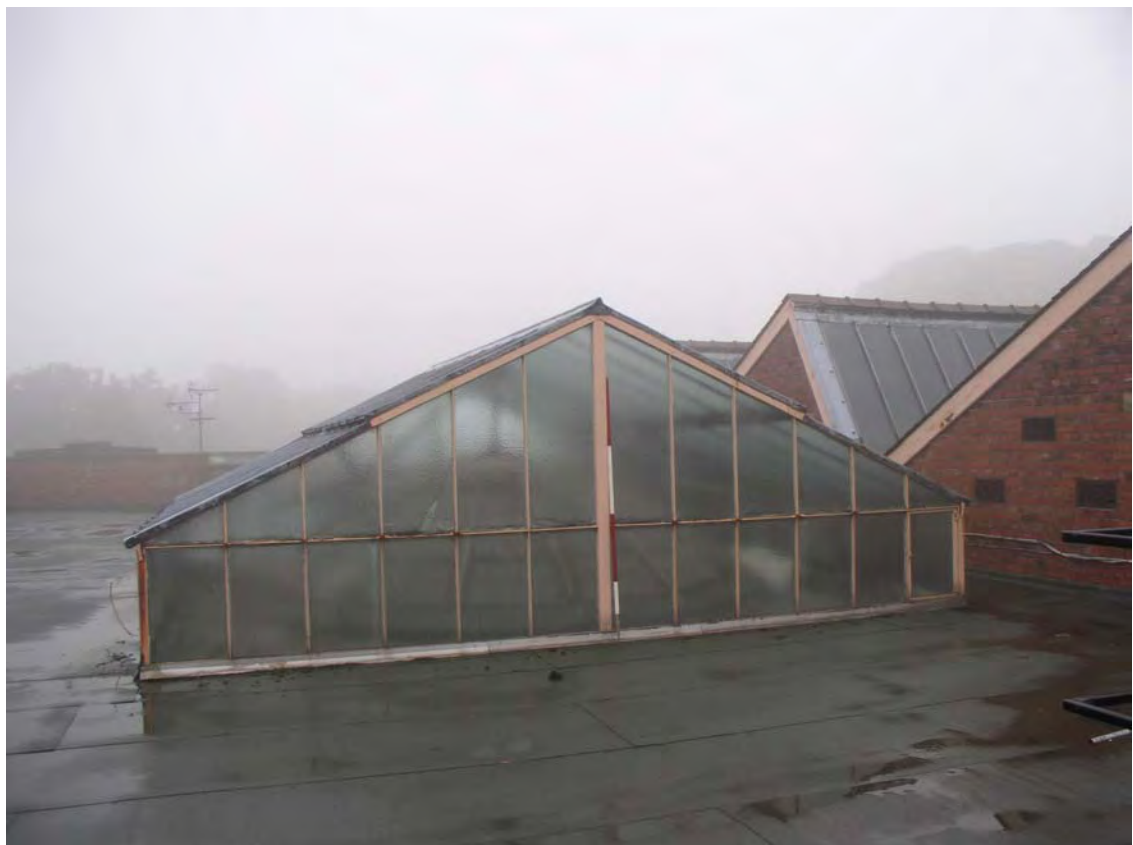
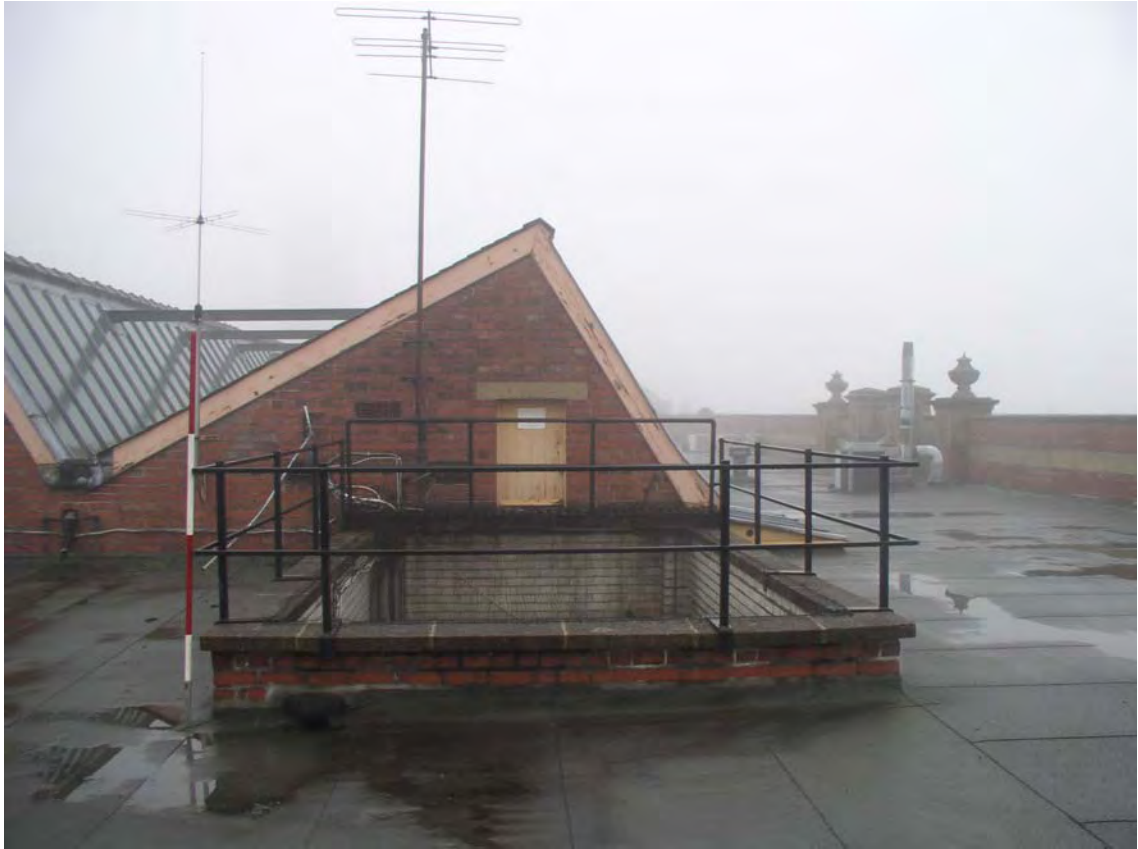
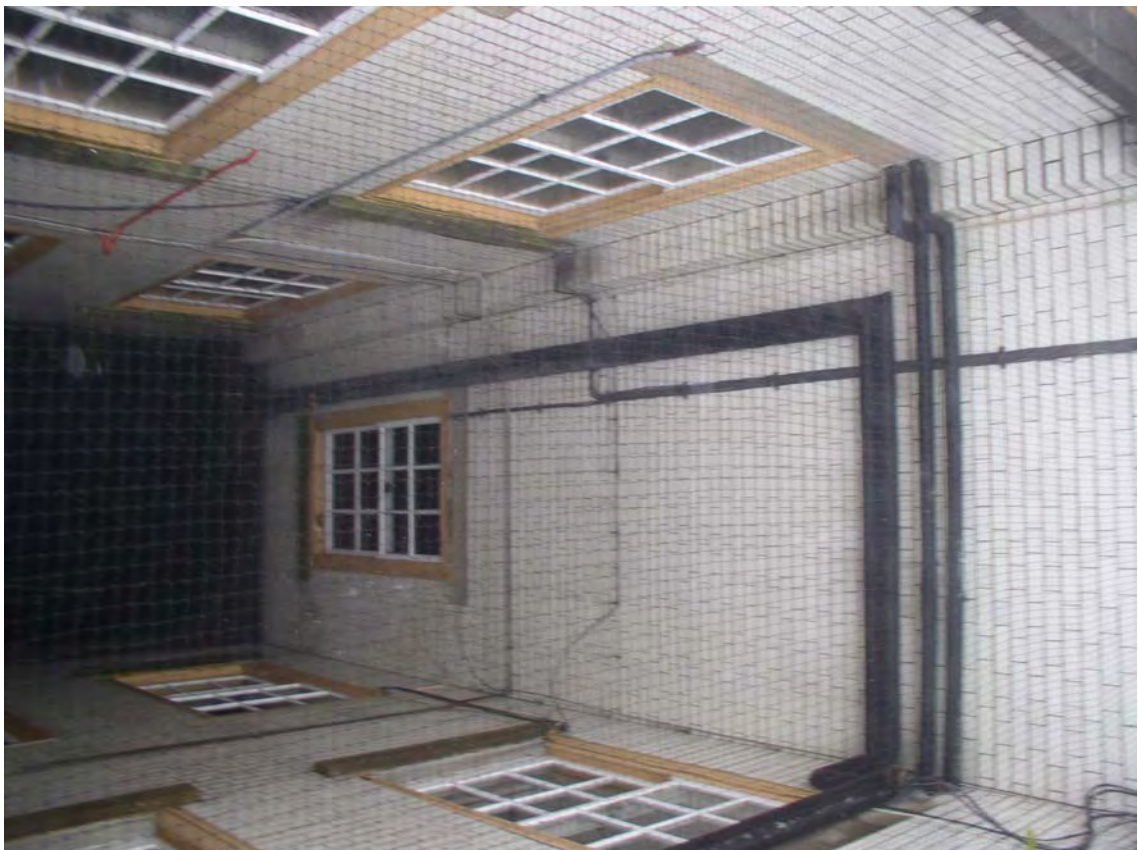
Plate 120. Head Office Roof. Facing North.

Plate 121. Head Office Roof. Facing South.

Plate 122. Head Office Roof. Facing North.

Plate 123. Head Office Roof. Facing West.

Plate 124. Head Office Roof. Facing West.

6.5.4 The Roof has accesses from the east, west and central staircases. There are two blocks housing the air-conditioning plant. There is also a large tank and several vents and associated plant.

On the roof are several entrances from the staircases at the east and west ends and the central main staircase. There are also two structures containing the original air-conditioning plant, and a large (water) tank.

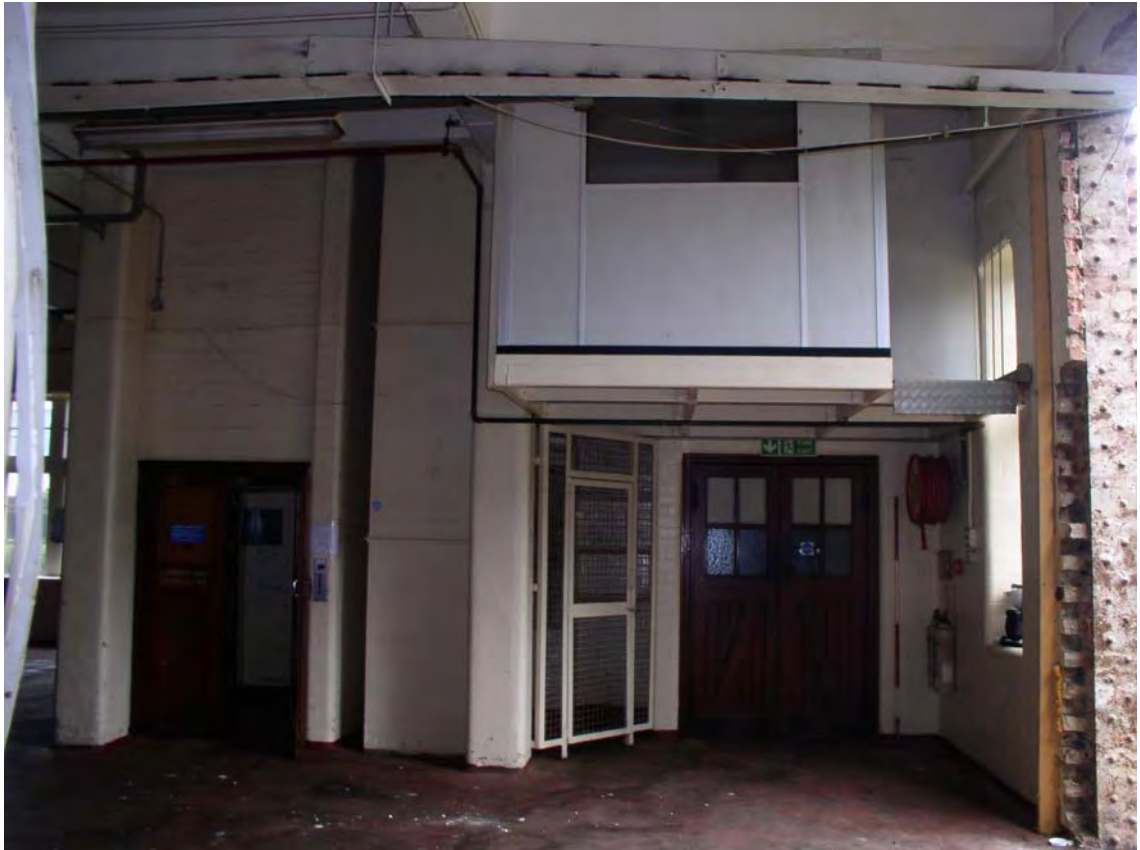
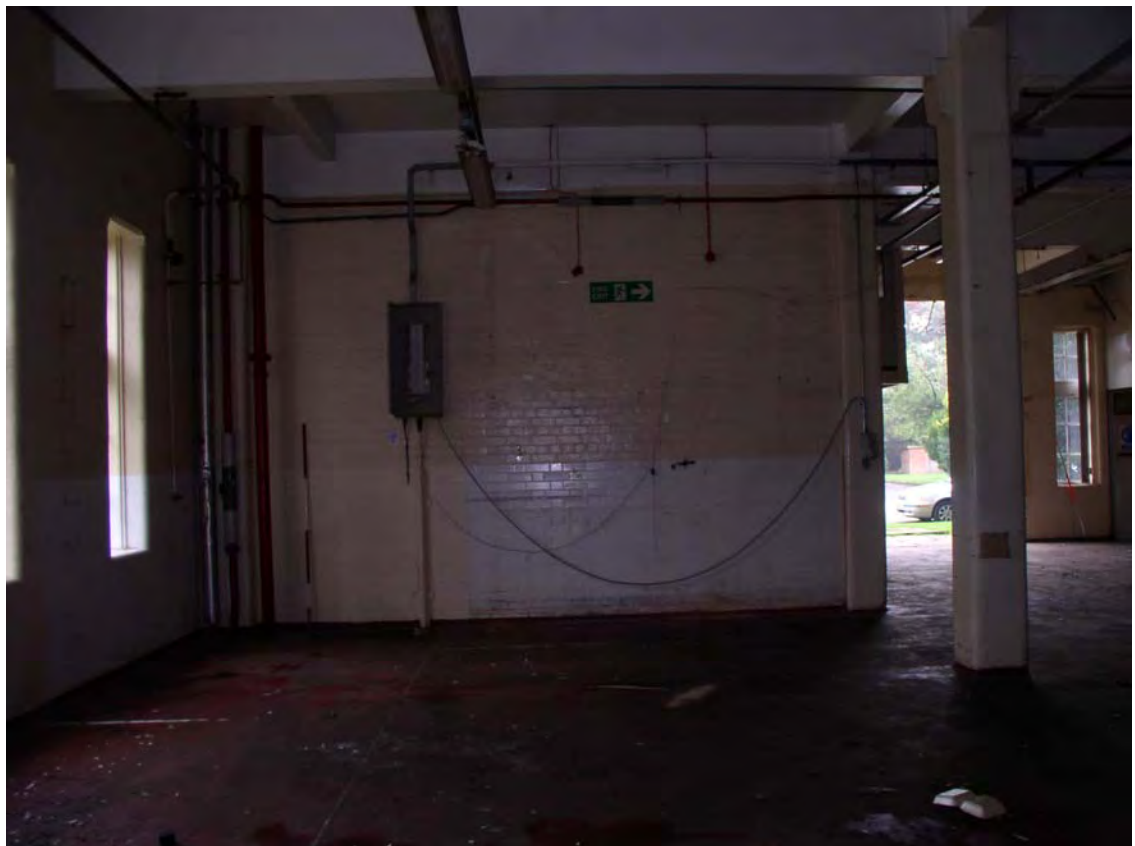
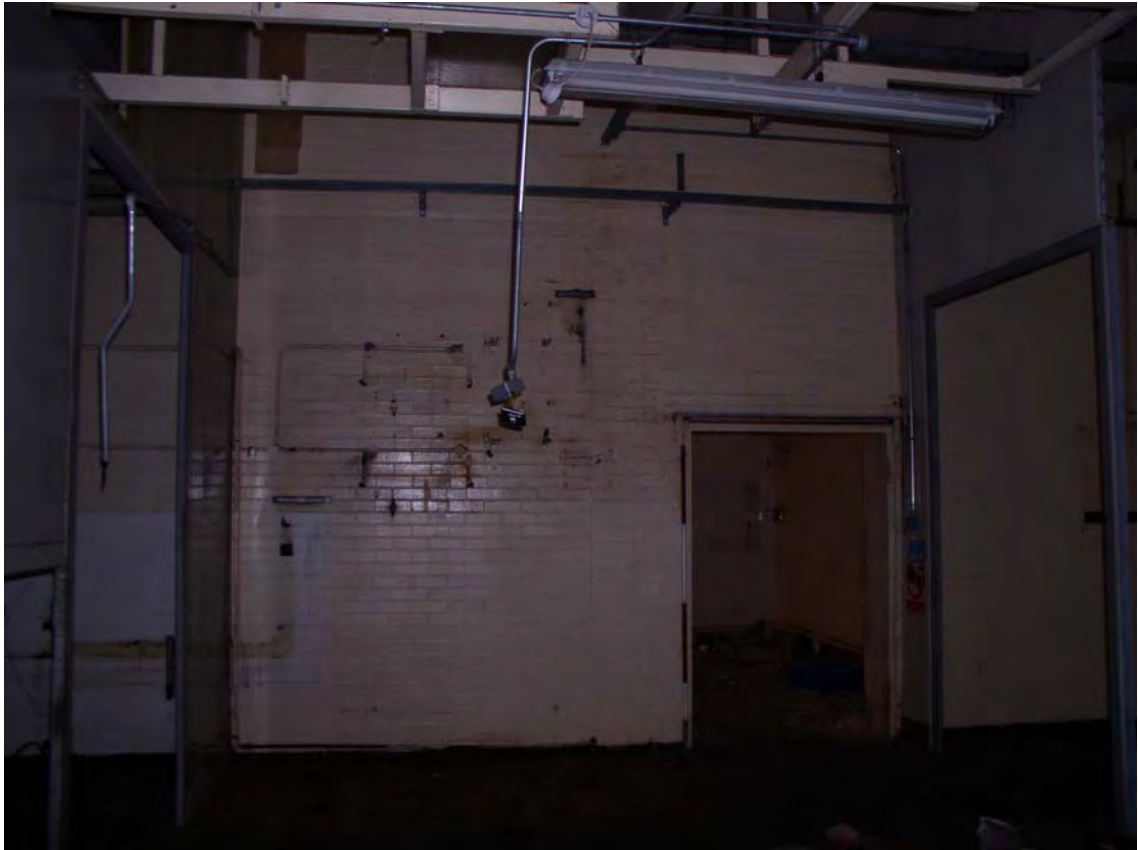
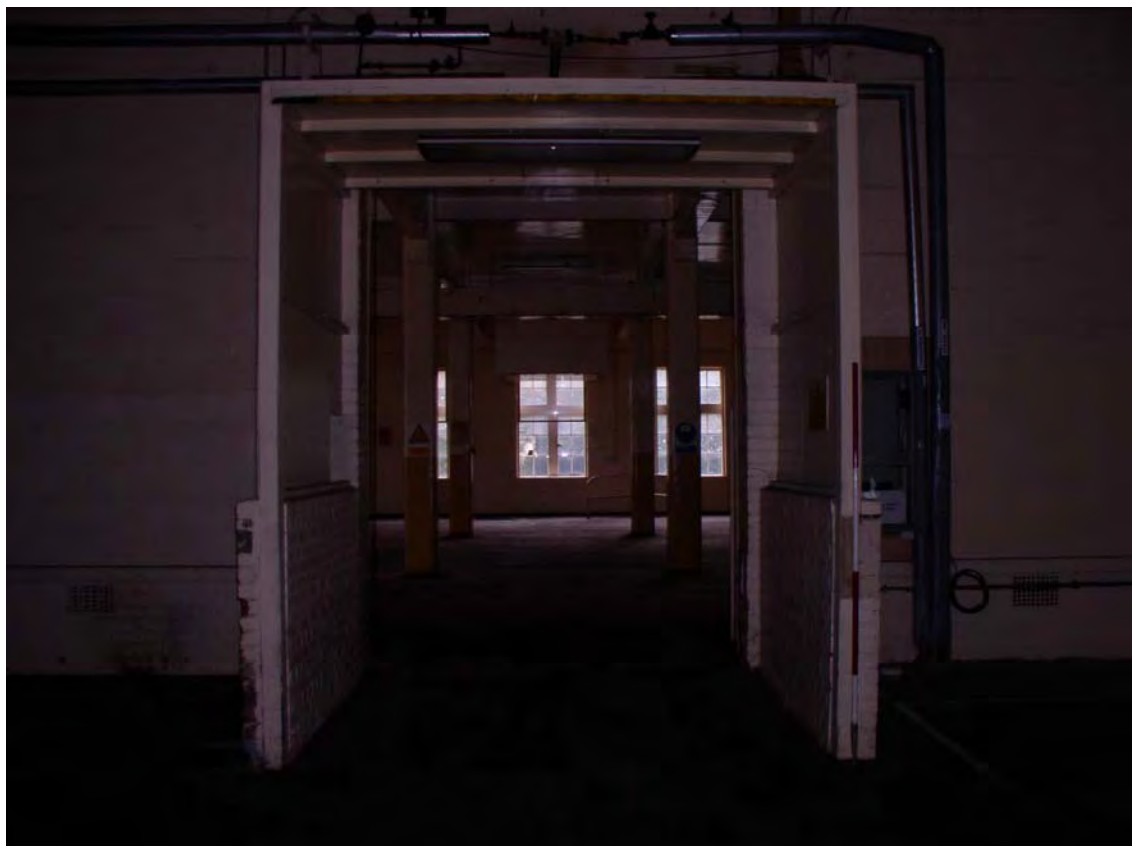
Plate 139. Factory. Ground Floor Interior. Facing North.

Plate 140. Factory. Ground Floor Interior. Facing East.

Plate 141. Factory. Ground Floor Interior. Facing East.

Plate 142. Factory. Ground Floor Interior. Facing East.

In the interior of the factory, the ground floor shows the most changes. The south facing windows have been blocked, and new entrances inserted to connect with the southern factory building. Some older glazed partitions and offices are seen on the upper floors. More modern partitions for machinery are also seen on the open plan floors. The lavatories and cloakrooms are in original detail, with some modern sub-divisions. The air-conditioning and ceiling fixtures are still in place. Floor weighing scales are visible on two floors. There is a goods lift between the ground and the third floor. Of note are the double windows in a room between the inserted goods lift and west staircase on the third floor, suggesting the brick partition is of later construction.

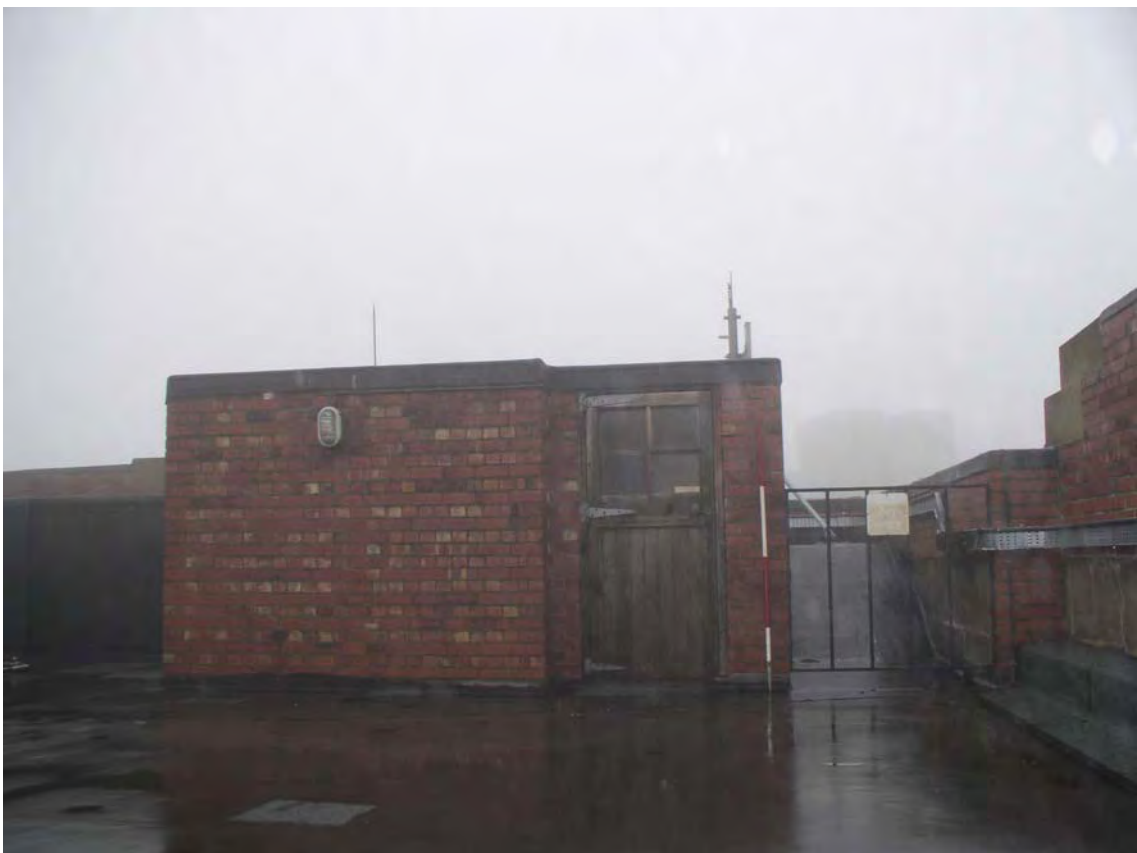
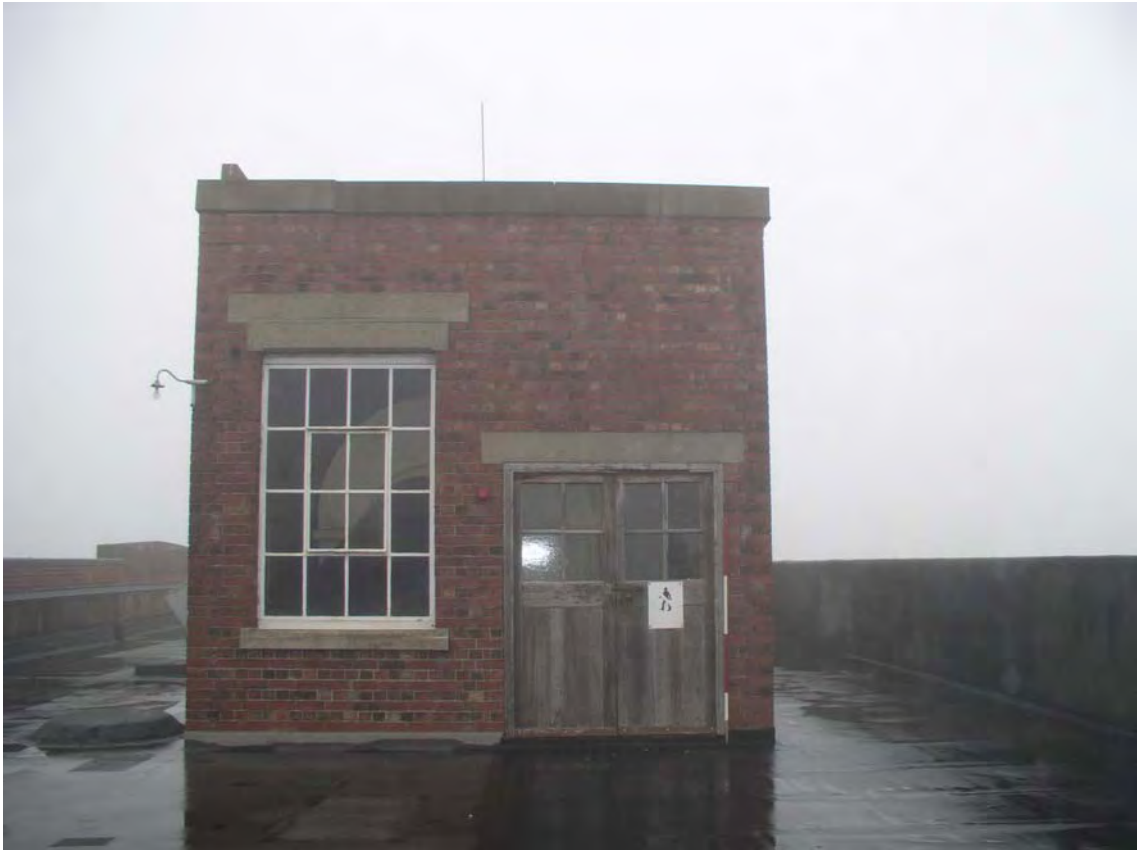
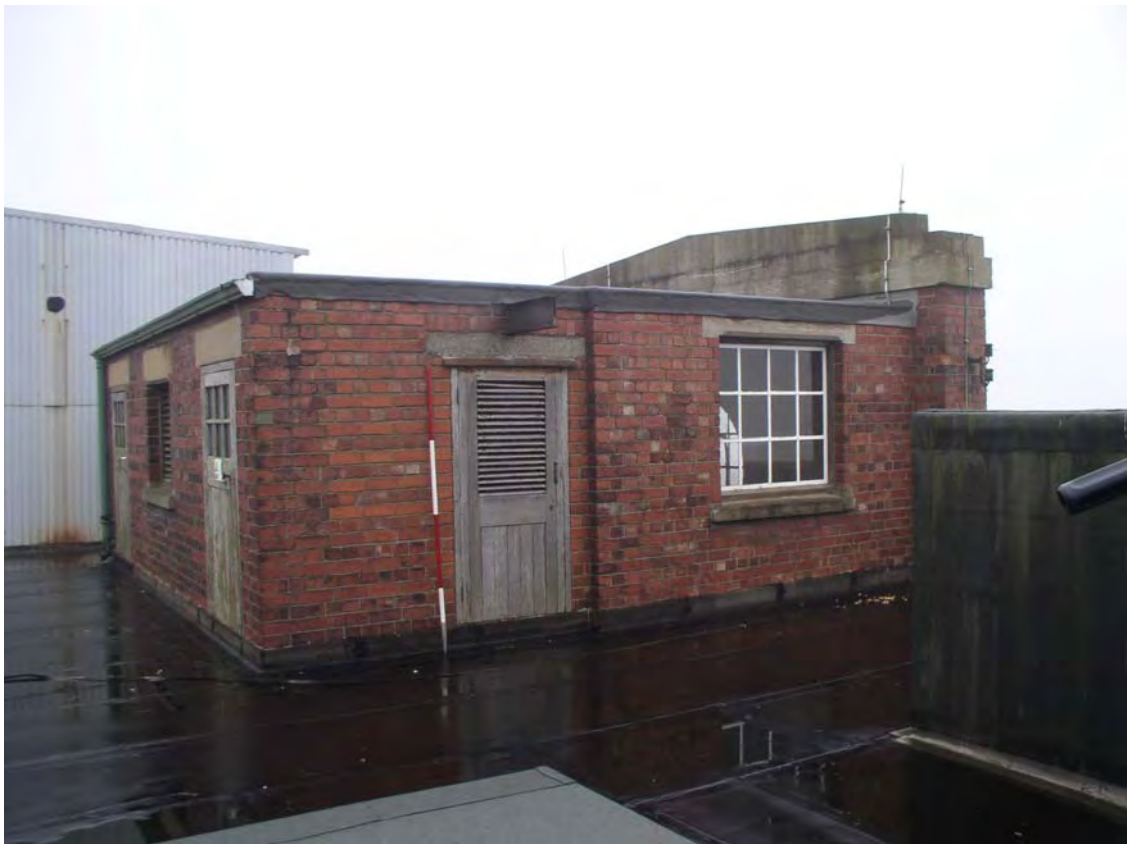
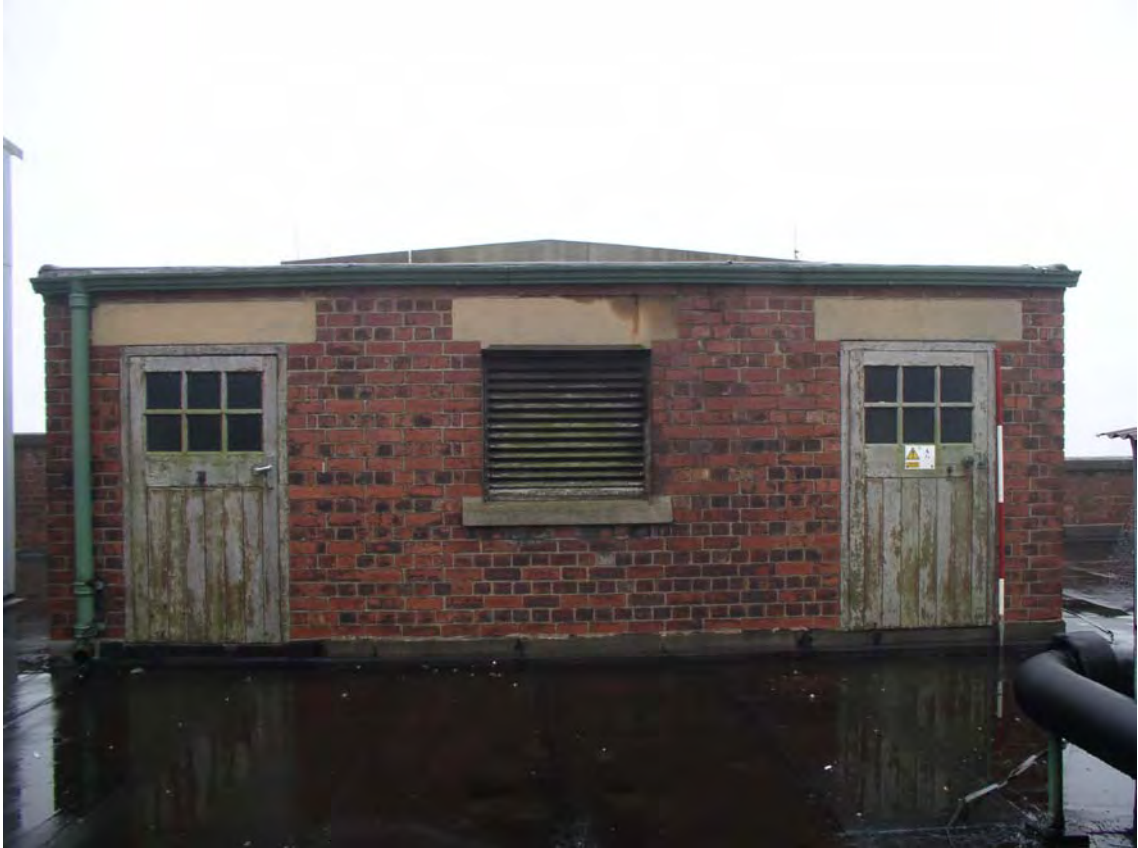
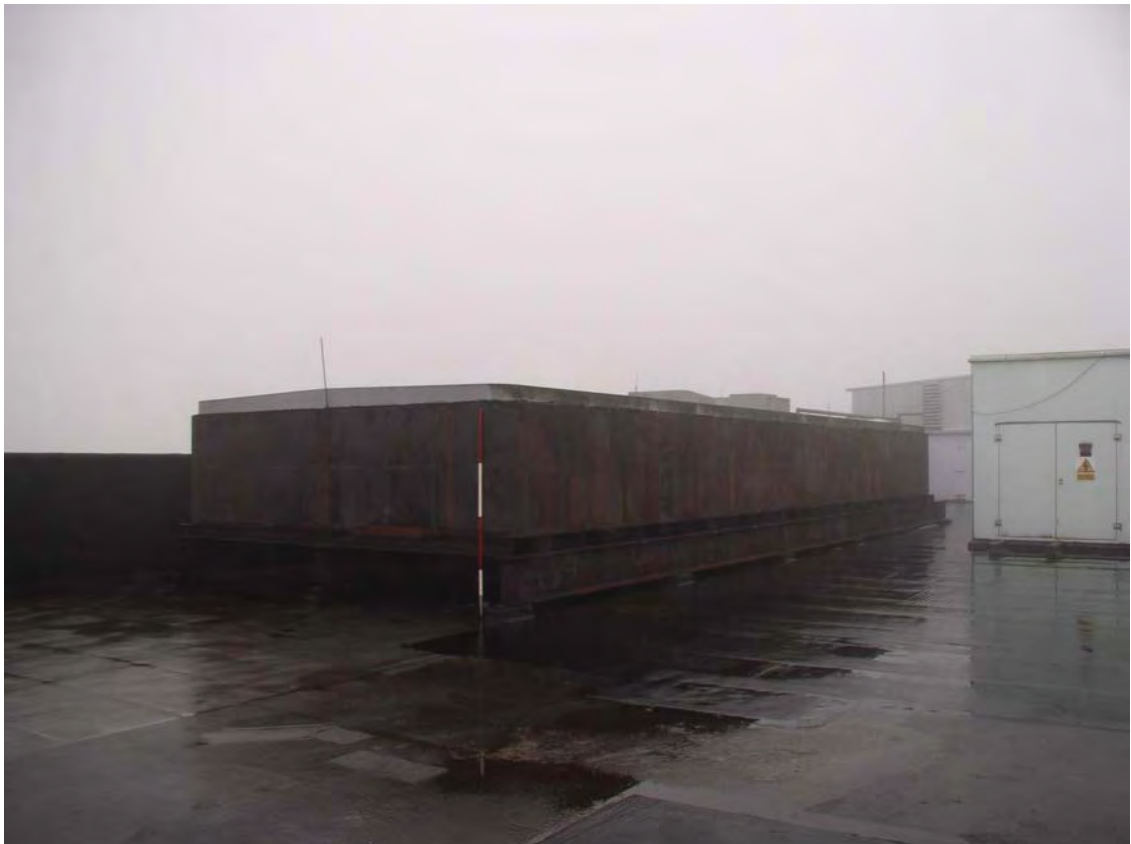
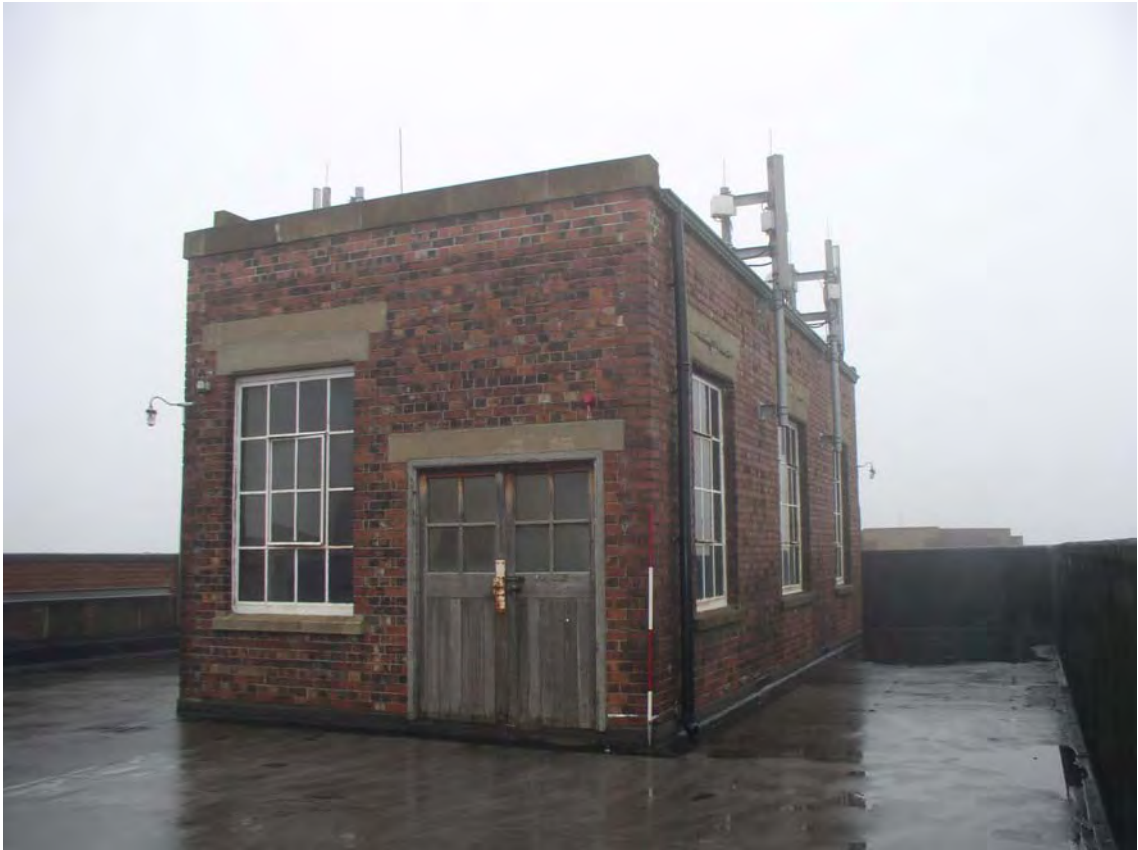
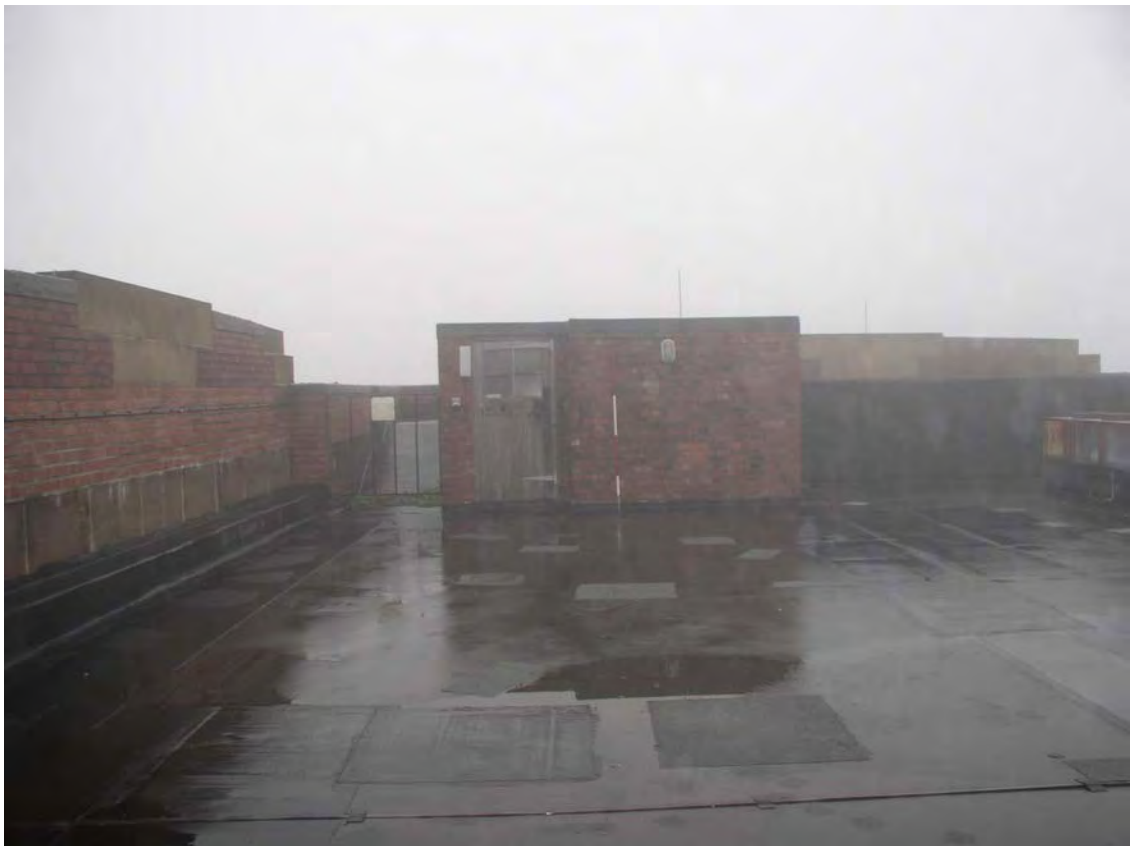
Plate 182. Factory. Roof. Facing West.

Plate 183. Factory. Roof. Facing East.

Plate 184. Factory. Roof. Facing East.

Plate 185. Factory. Roof. Facing South.

Plate 186. Factory. Roof. Facing South-west.

Plate 187. Factory. Roof. Facing East.

Plate 188. Factory. Roof. Facing East.
