KNAVESMIRE SCHOOL, CAMPLESHON ROAD, YORK.

REPORT ON
AN ARCHAEOLOGICAL WATCHING BRIEF
OSA REPORT No: OSA13WB07

February 2013

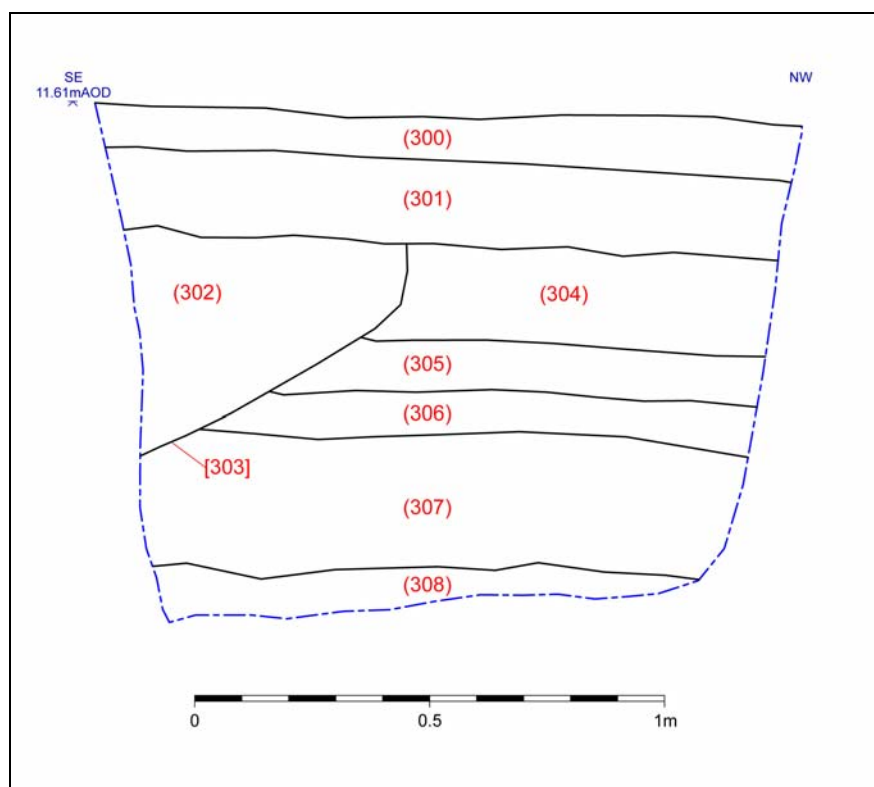
Figure 3. Northeast facing section manhole Trench 3.

Trench 3 was a run of drainage roughly aligned north to south to the east of Trench 1 (Figure 2). This was excavated to a maximum depth of 1.1m and a minimum of 0.75m (Plate 5). For the most part the trench along its northern half had a similar sequence of deposits as those recorded within Trench 2. A manhole located to the southern extent of the trench revealed natural (308) comprising of a reddish-brown sandy-clay at approximately 10.61mAOD (Figure 3; Plate 6). This was sealed by a probable plough/subsoil layer (307) that was 0.3m deep and consisted of brown sandy-clay silt with occasional gravel stone, rare CBM and charcoal fleck inclusions. The CBM inclusions within (307) appeared to be indicative of post-medieval or later material. Sealing layer (307) was a former land surface soil (306) that was 0.09m deep and comprised of a dark greyish-black clayey-silt with occasional charcoal inclusions. A small fragment of clay pipe stem of an early modern date was recovered from layer (306).

Above layer (306) was a compacted layer (305) that was 0.11m deep and consisted of a pinkish-brown sandy-silt with frequent pebble stone inclusions. No finds were recovered

from (305), which probably represented an area of former hard standing or possible road/track material. Sealing (305) was an early modern tipping (304) that was 0.2m deep and comprised of lenses of sandy-silts, ash and cinder. This layer was truncated by a service trench [303] that contained a single fill (303) of a grey clayey-silt with occasional 19th/20th century CBM inclusions. Overlying the service trench was a levelling/make up deposit (301) that was 0.2m deep that provided a base for the playground tarmac surface (300).

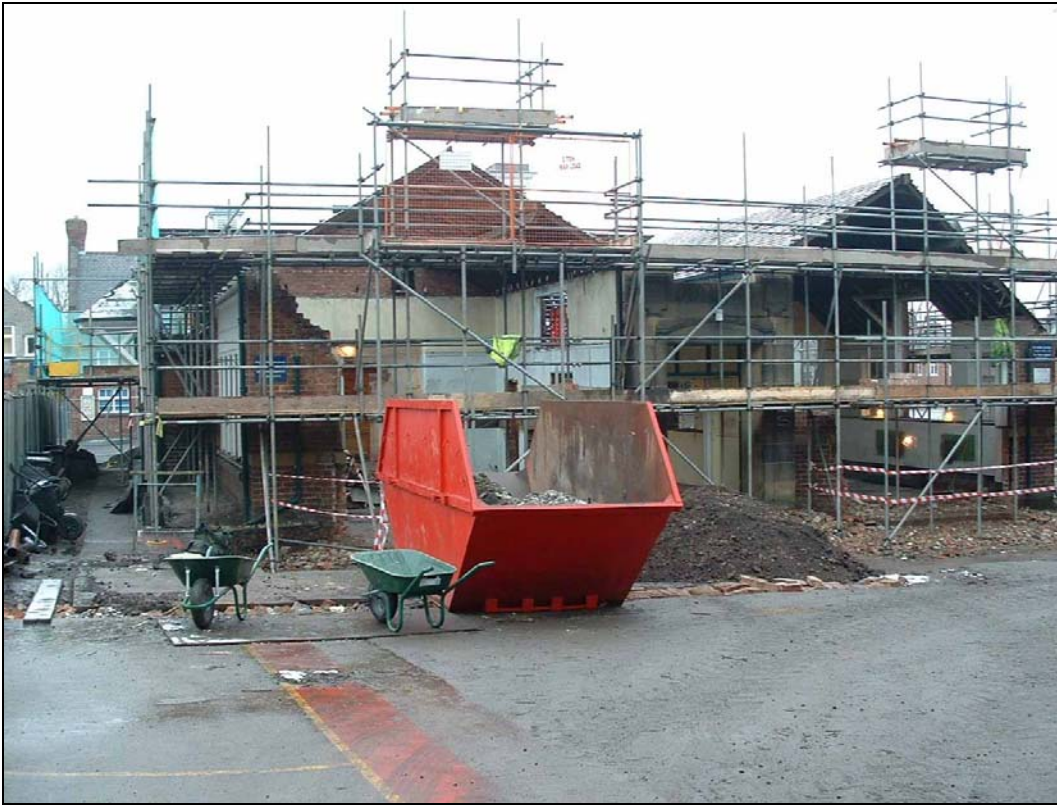
Plate 1. Trench 1, footprint of school building extension looking north.

Trench 1 covered the footprint of the school building new extension (Figure 2; Plate 1). It was excavated to a maximum depth of 0.6m BGL (below ground level) to the west and 0.2m BGL to the east. The natural (104) comprised of a pale yellowish-brown sandy-clay, was encountered at 0.58m BGL within the southwestern corner of the trench section (Plate 2). This was sealed by a dark greyish-black clayey-silt layer (103) that measured 0.1m deep and contained occasional charcoal inclusions. No finds were recovered from layer (103) that probably represented a former land surface, most likely of a pre-19th century date, possibly post-medieval. Overlying layer (103) was a black/red clinker tipping layer (102) that was 0.1m deep. This was sealed by layer (101) that measured 0.15m deep and was comprised of a mid-brown clayey-sandy-silt with frequent CBM (ceramic building material) inclusions. This layer provided a levelling/base for the above playground tarmac surface (100) that was 0.16m deep.

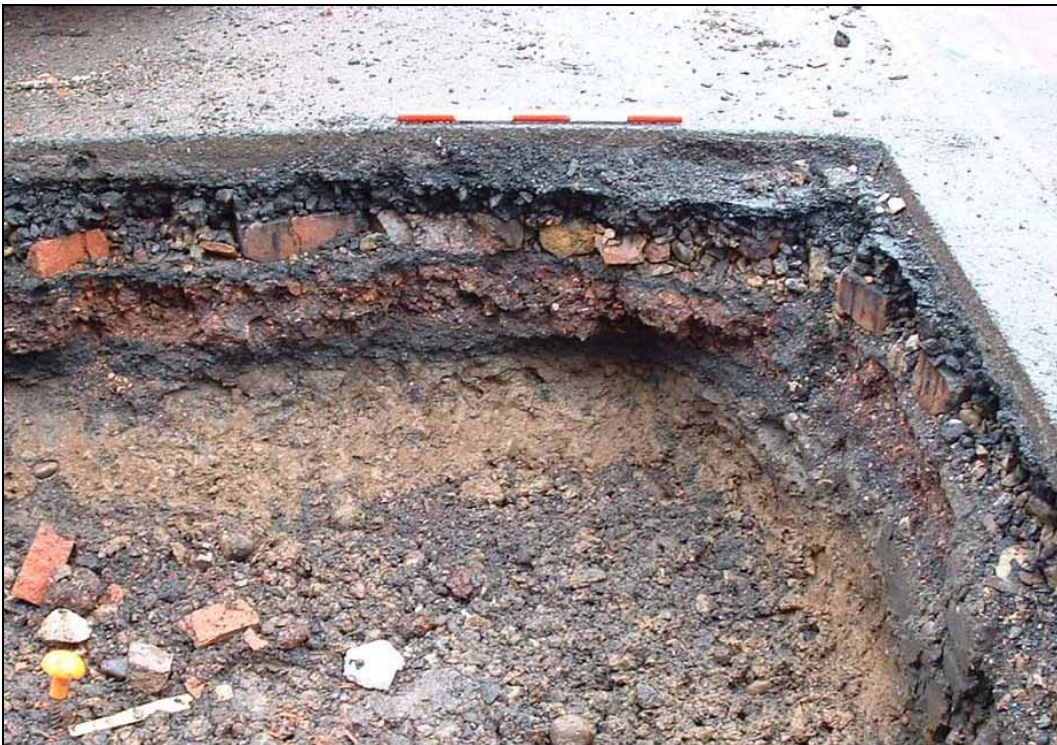
Plate 2. Trench 1, southwest corner looking south.

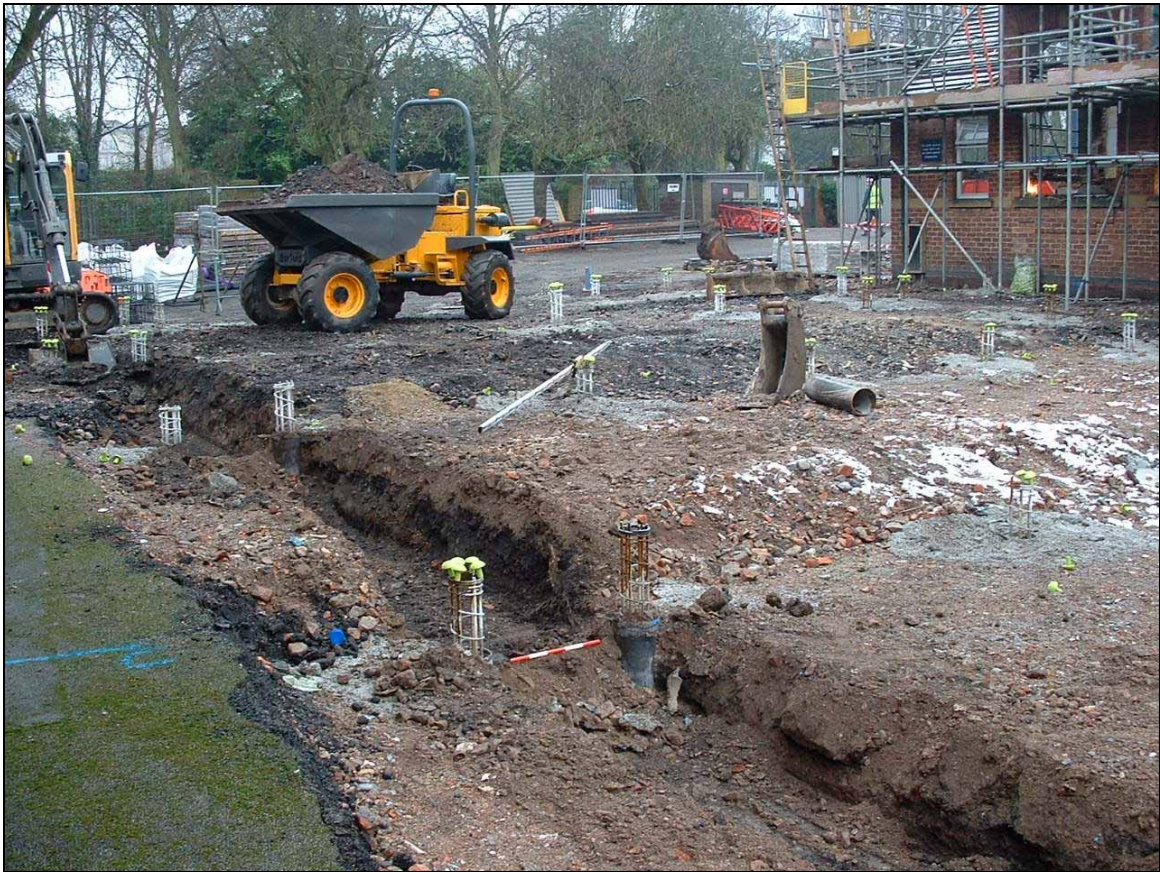
Plate 3. Trench 2 linking trenches looking southwest.

This trench covered the footprint of a new school hall building and involved monitoring a number of foundation linking trenches between previously installed piling caps (Figure 2; Plate 3). The linking trenches were approximately 1m wide and had a maximum depth of 0.75m BGL. The natural deposits were not encountered during the excavation of the trenches. The earliest deposits appeared to represent probable tipping layers (Plate 4). Layer (206) was exposed for a depth of 0.04m and comprised of brown sandy-silt with occasional mortar and gravel inclusions. This was sealed by a greyish-white chalk fragment layer (205) that was 0.05m deep. Above (204) was layer (203) that consisted of a pale yellowish-brown sandy-clay re-deposited natural that was 0.1m deep. The final tipping layer was (202) that

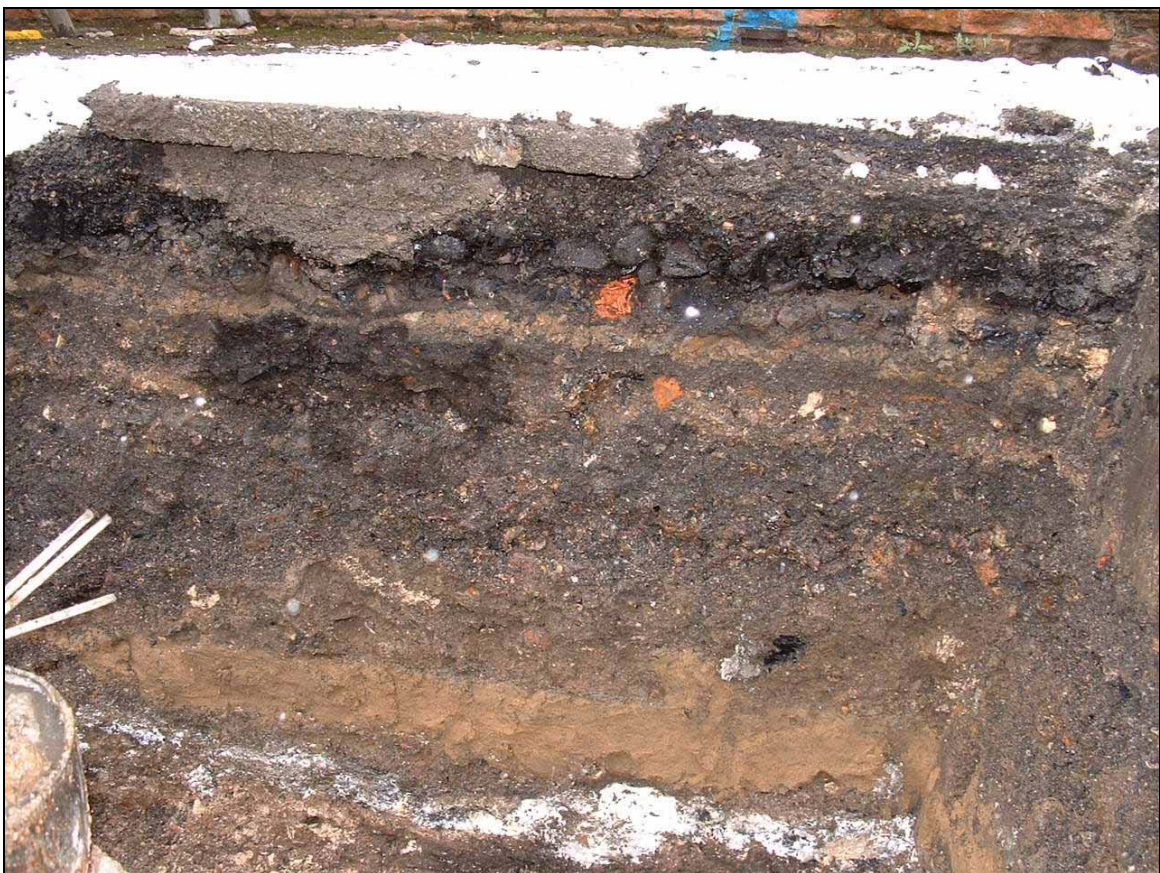
Plate 4. Trench 2 east facing section looking west.

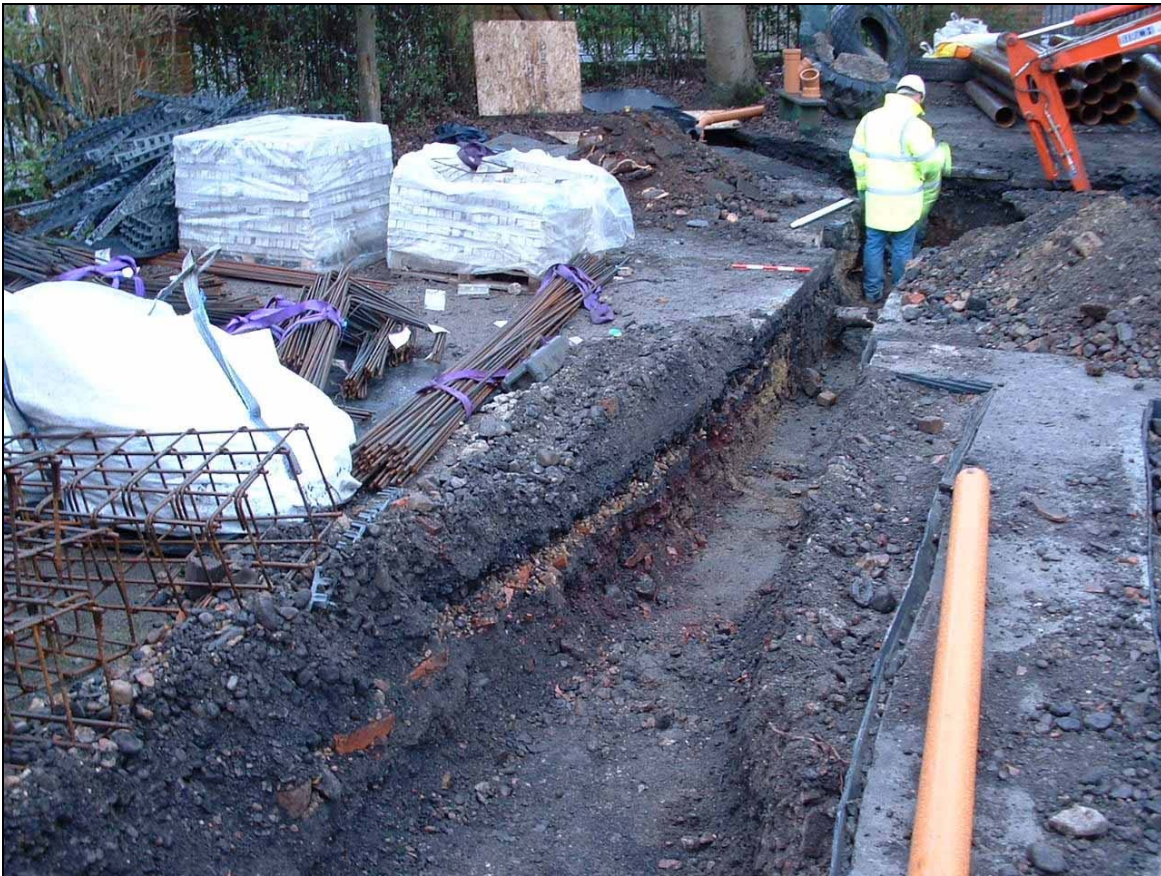
Plate 5. Trench 3 drainage trench looking southeast.

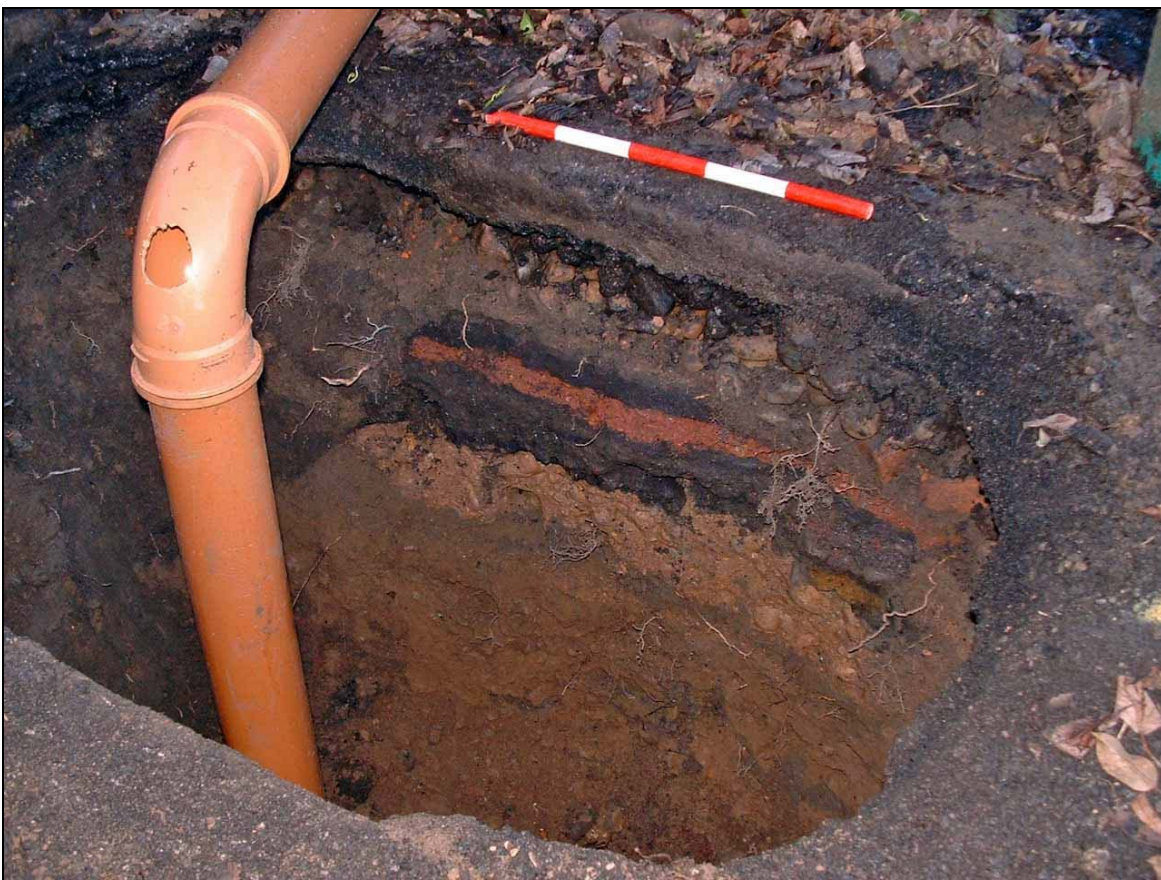
Plate 6. Trench 3 manhole, northeast facing section looking southwest.

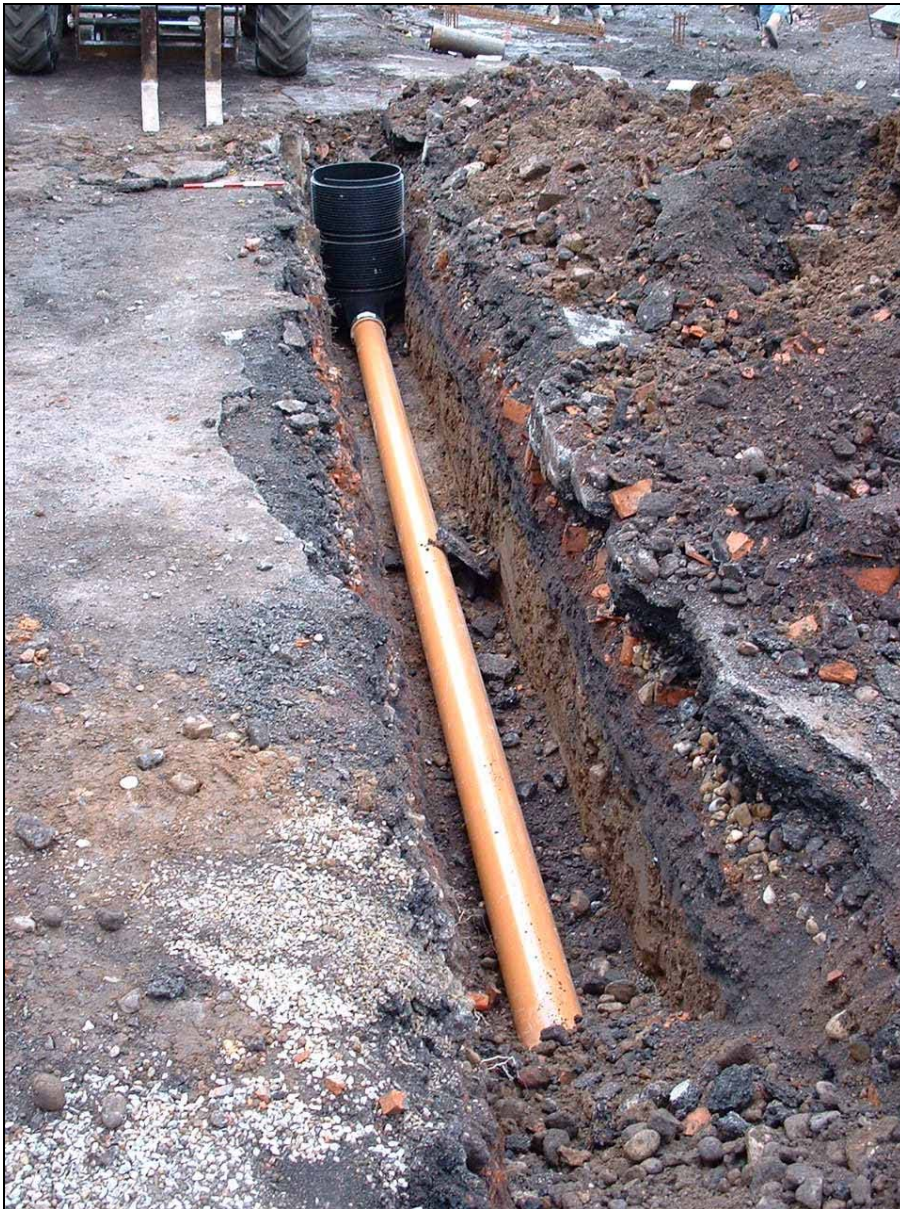
Plate 7. Trench 4 drainage trench looking west.

This trench ran along the northern sides of Trench 1 and 2 (Figure 2; Plate 7). Trench 3 excavated to a maximum depth of 1m. This trench revealed almost a similar sequence and description of deposits recorded within Trench 3. These included natural (405) sealed by a plough/subsoil (404) that was 0.4m deep. Sealing (404) was a 0.1m deep former land surface (403). Overlying this was a levelling/make up deposit (401) that was 0.28m deep sealed by playground tarmac surface (400).
