MUSEUM GARDENS, YORK

Tree Planting Survey

Museum Gardens, York

A Report on the Feasibility of Tree Planting

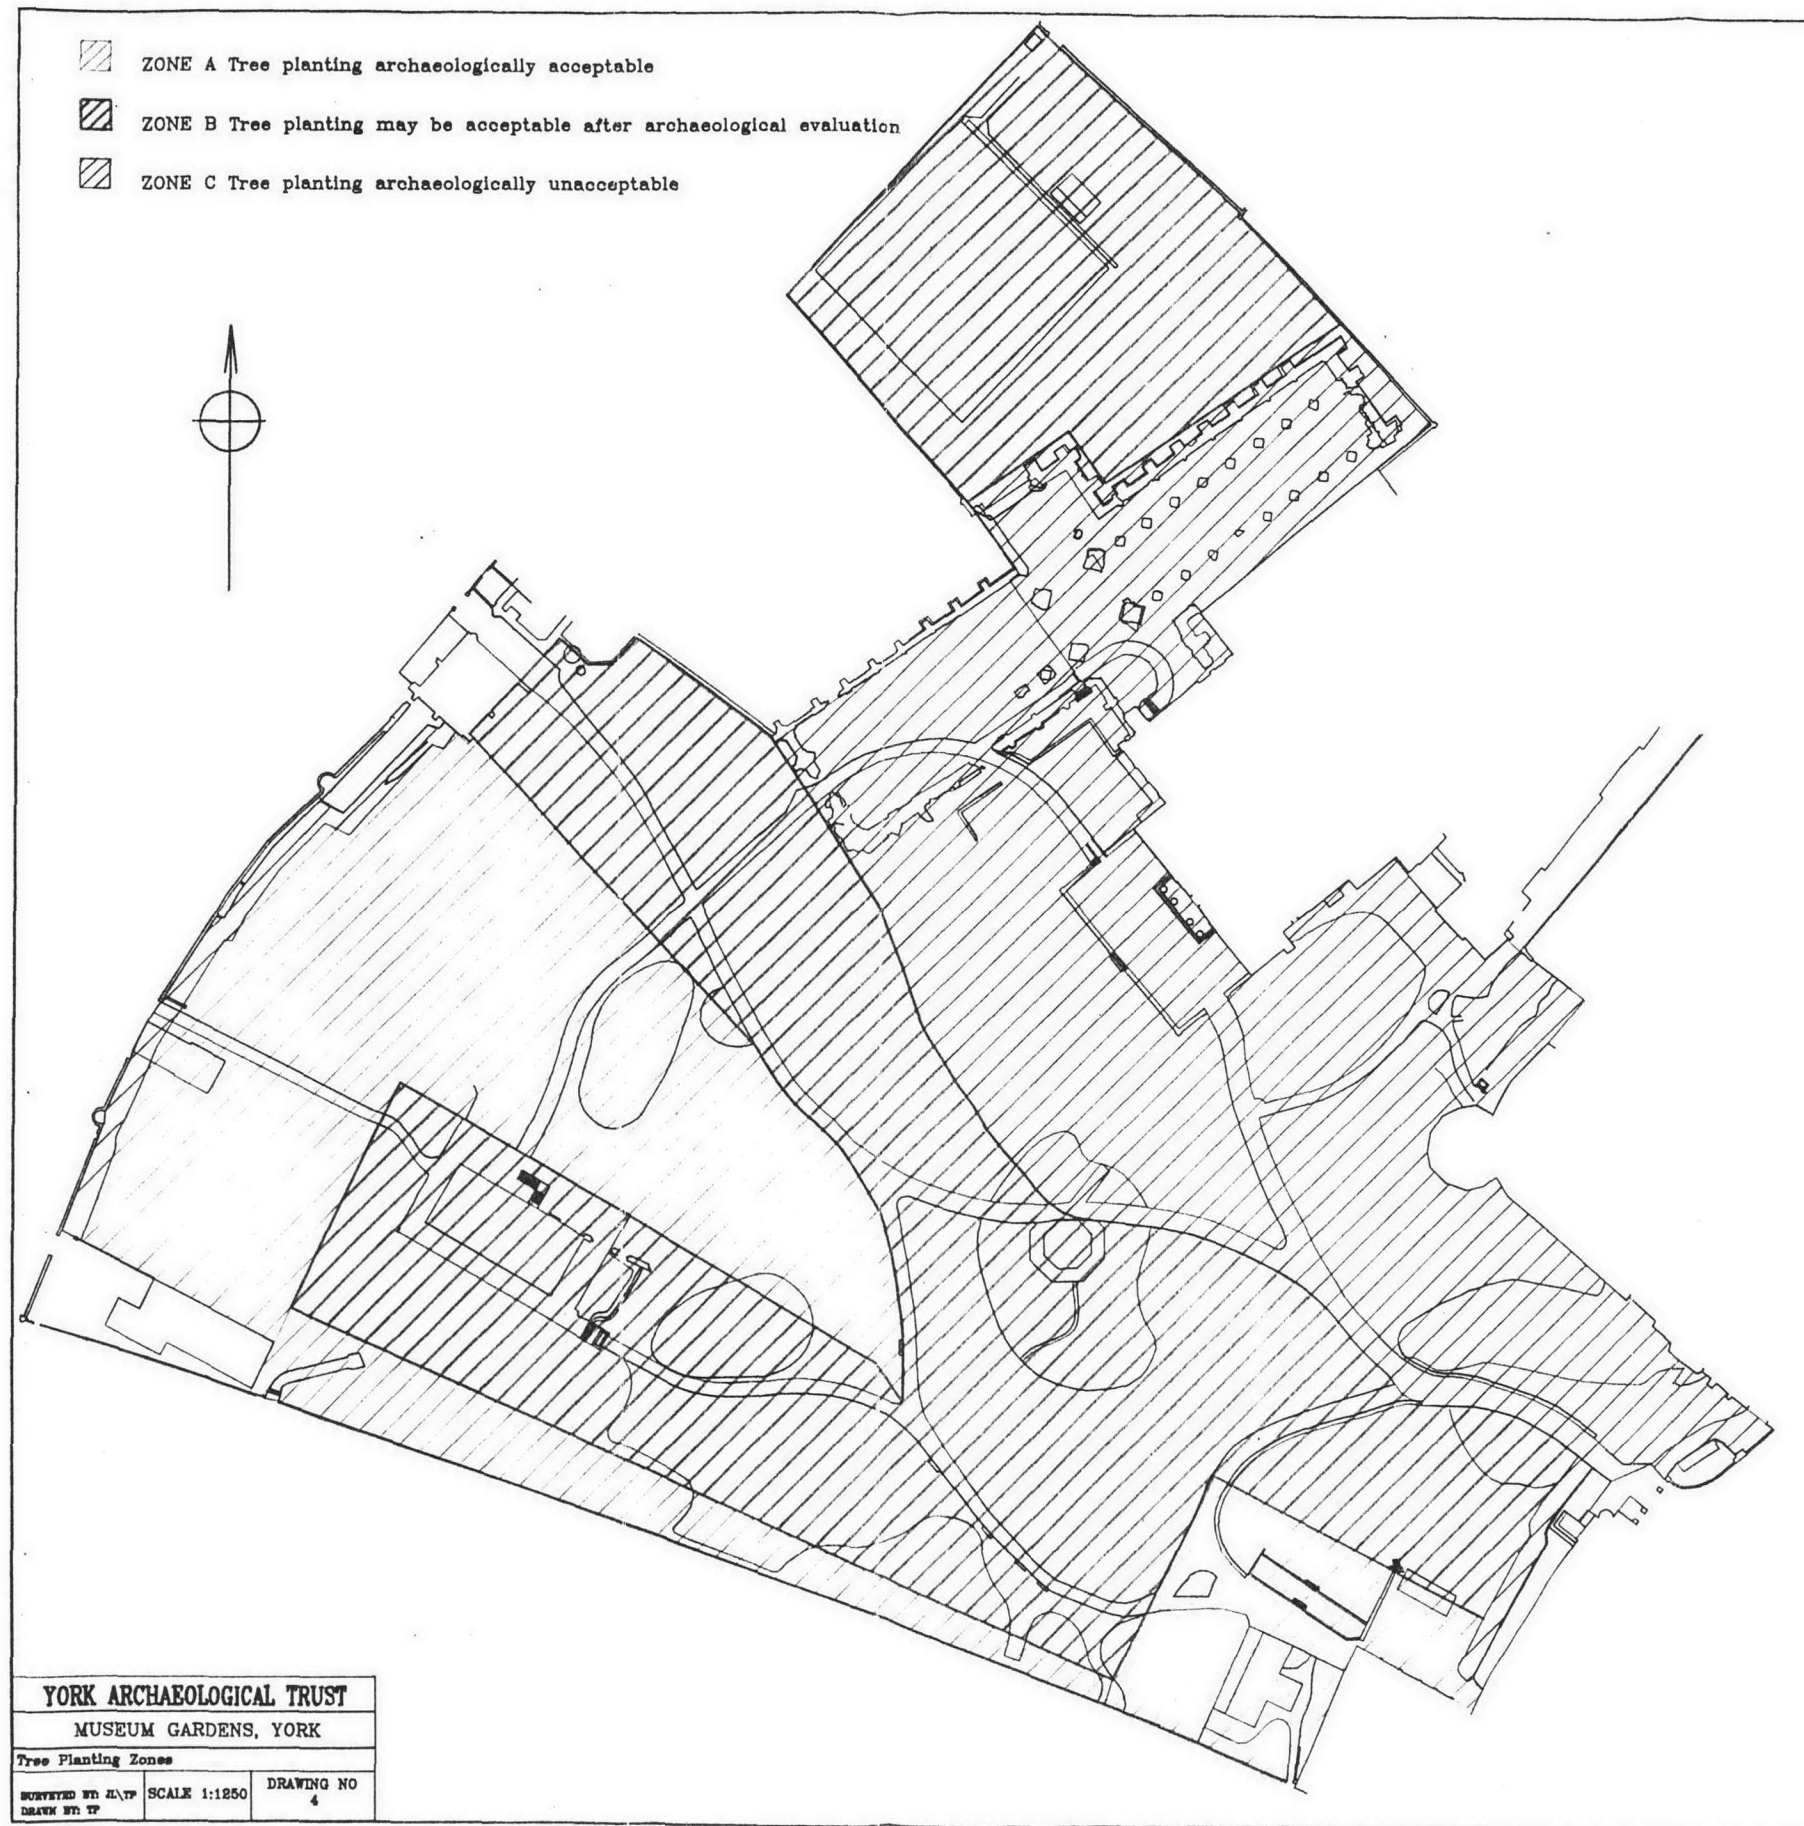
- Fig. 1 Contour Survey of Museum Gardens
- Fig. 2 Archaeological Interventions
- Fig. 3 Structural Remains
- Fig. 4 Zones for tree planting

The zones identified on Figure 4 have been largely dictated by the presence of archaeological remains. In order to facilitate garden management however, modern topographical features have been used as boundaries where possible.

It has proved possible to define areas within Museum Gardens where tree planting would cause minimal archaeological disturbance. Zone A on figure 4 delineates an area over the 19th century swimming pool, to the riverward side of the Abbey Precinct wall, around the public toilet block and between the Hospitium and the Abbey Gatehouse in which, as far as can be reasonably predicted, archaeological deposits are unlikely to be affected.

Zone C on figure 4 shows that part of Museum Gardens in which important archaeological deposits are known to exist at relatively shallow depth. These consist largely of the structural remains of St Mary's Abbey, the majority of which have been proved by excavation, the defences of the Roman legionary fortress and an ill understood series of Roman structural remains to the north-west of the legionary fortress. All of these remains are close to the surface and would suffer significant damage if trees were planted above them. This zone also includes the City Bank on the south-east edge of the gardens and a narrow strip adjacent to the Abbey precinct wall along the north-western boundary.

The remaining areas, marked Zone B on figure 4, are those in which remains are suspected to exist but not currently proven archaeologically. In this area it seems reasonable to insist that archaeological investigation should precede the planting of trees.
