ARCHAEOLOGICAL APPRAISAL

REHABILITATION OF WATER MAINS

YORK AREA

NAA 08/112
November 2008

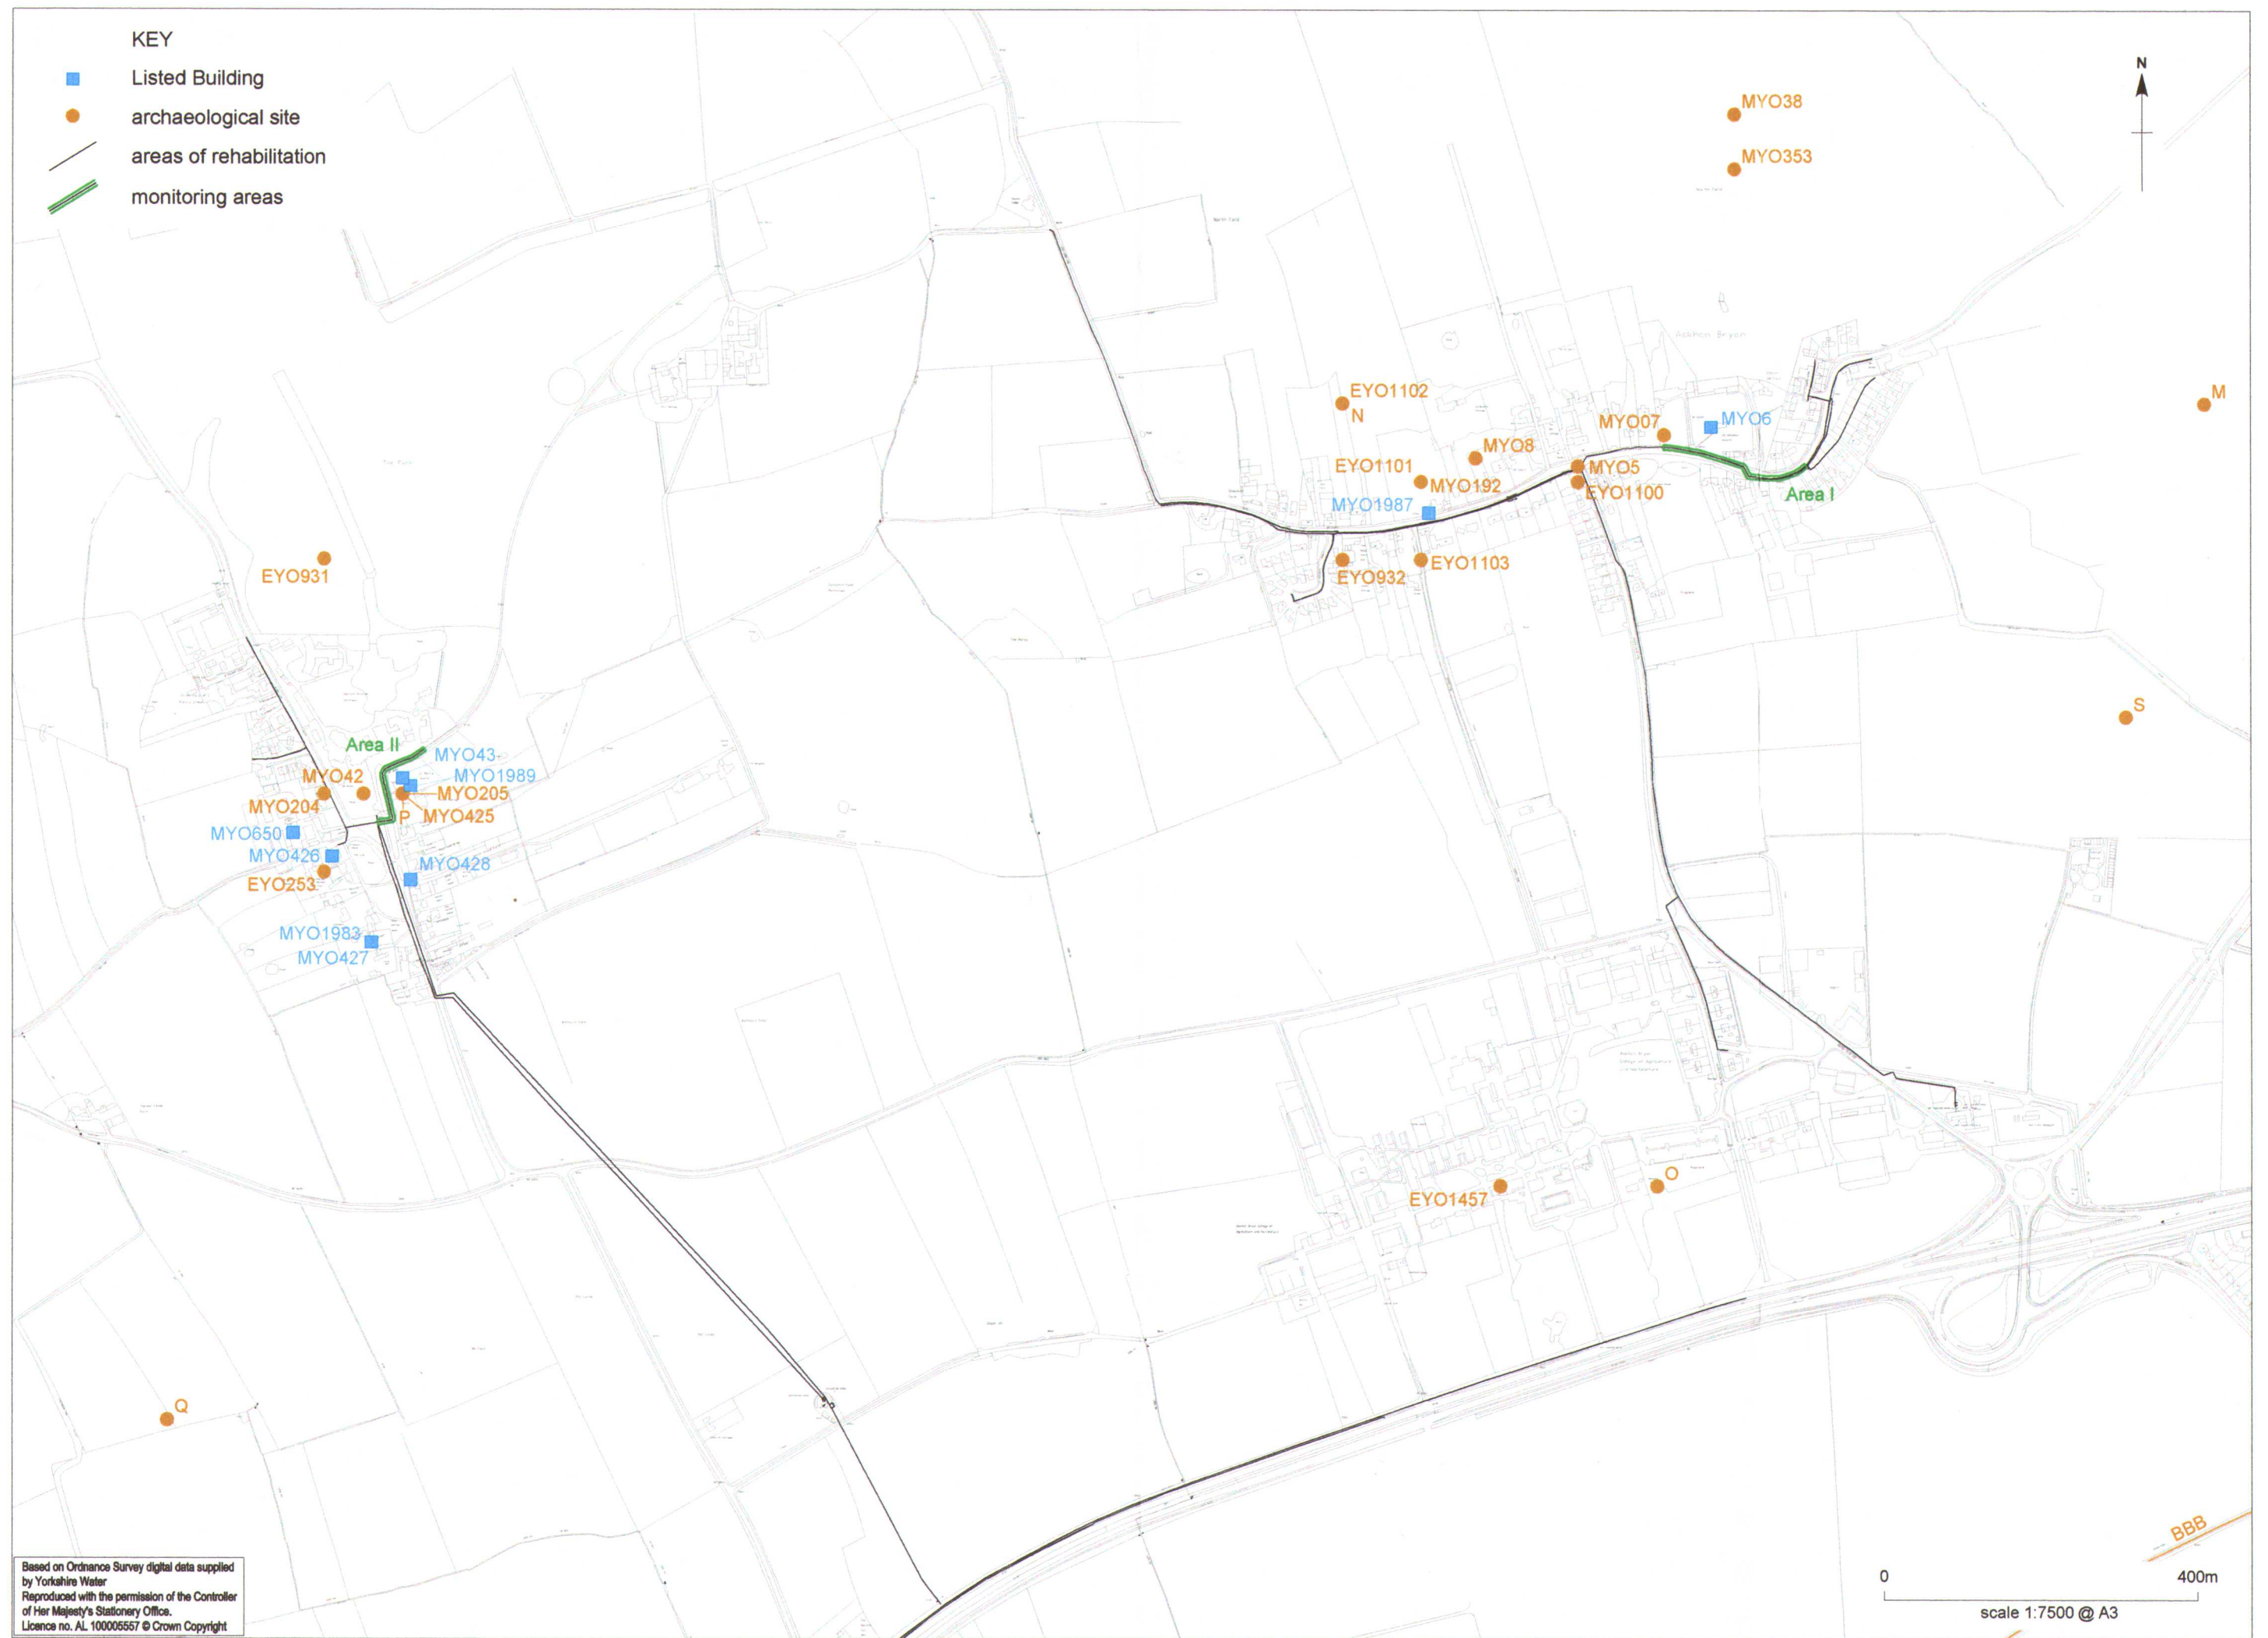
- 3.2 The relining works will pass in close proximity to the Church of St Nicholas and its suspected early medieval precursor (MY06), where medieval or later burials may be encountered. It is recommended that archaeological monitoring be undertaken for the excavation of pits between St Nicholas' church and Manor Farm (Area I).

- 3.3 The relining works will pass in close proximity to the Church of St Mary (MYO43), where medieval or later burials may be encountered. It is recommended that archaeological monitoring be undertaken for the excavation of pits to the north and west of St Mary's church (Area II).

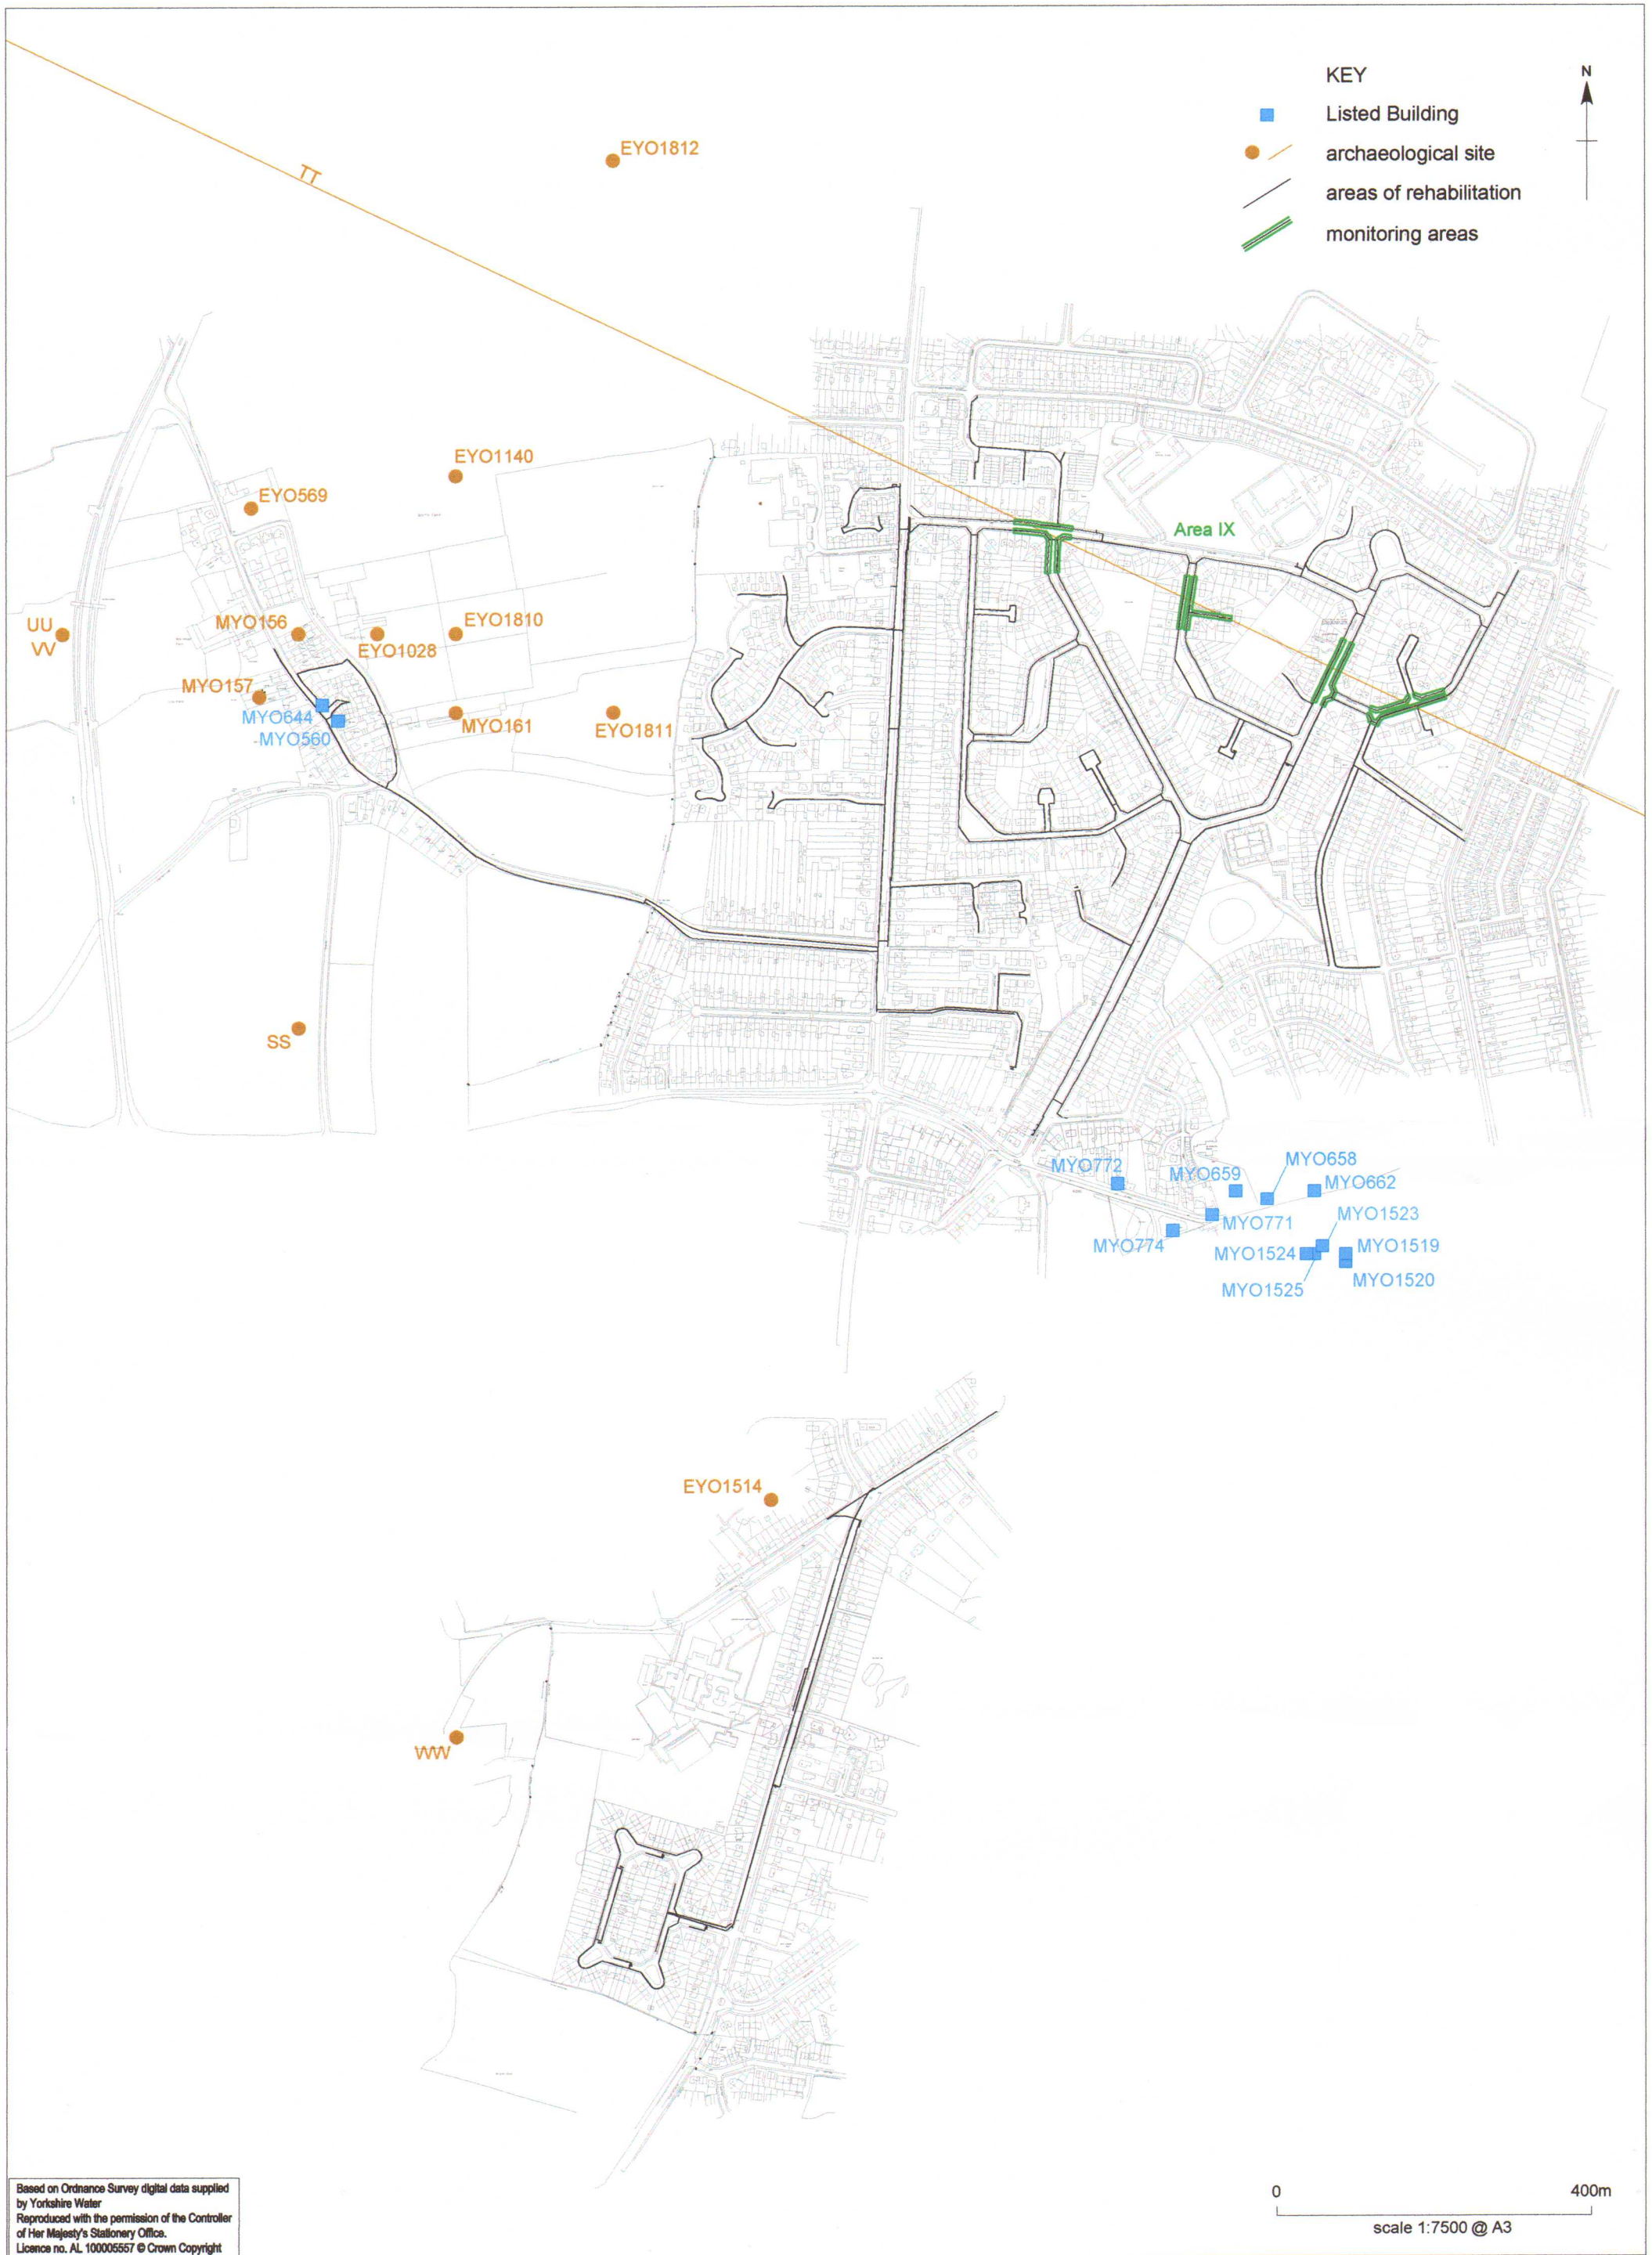
Figure 9 Rehabilitation of Water Mains, York Area: YO41 and YO48

- 3.12 The proposed works intersect the course of a Roman road (Site TT) at several points. It is recommended that archaeological monitoring be undertaken for the excavation of pits on Woodlea Avenue, Danebury Drive, Tostig Avenue and Ostman Road (Area IX) where the pipeline intersects the route of this Roman road.

- 3.13 The pipeline route does not directly impact on any recorded archaeological sites, therefore no archaeological monitoring is proposed.
- 3.14 The mitigation strategy should be undertaken to accord with Yorkshire Water's general duties in respect of conservation as required by the Water Industries Act (1991) and in accordance with a standard Scheme of Archaeological Monitoring (Appendix B).
